**CITY OF BEAUFORT**  
1911 BOUNDARY STREET  
BEAUFORT MUNICIPAL COMPLEX  
BEAUFORT, SOUTH CAROLINA 29902  
(843) 525-7070  
**CITY COUNCIL WORKSESSION AGENDA**  
**June 11, 2024**

**Henry C. Chambers Waterfront Park**  
Relieving Platform and Seawall Condition Assessment  
2024

# Henry C. Chambers Waterfront Park

### Structural Evaluation - 2024

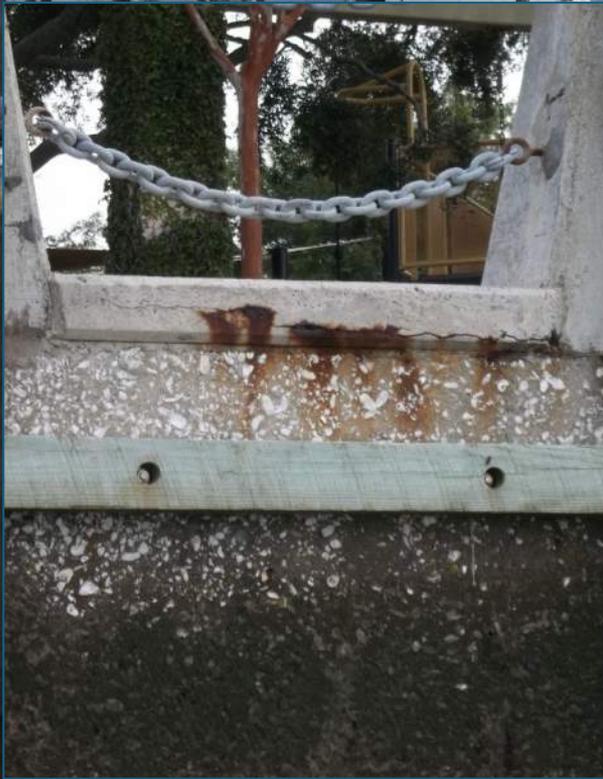
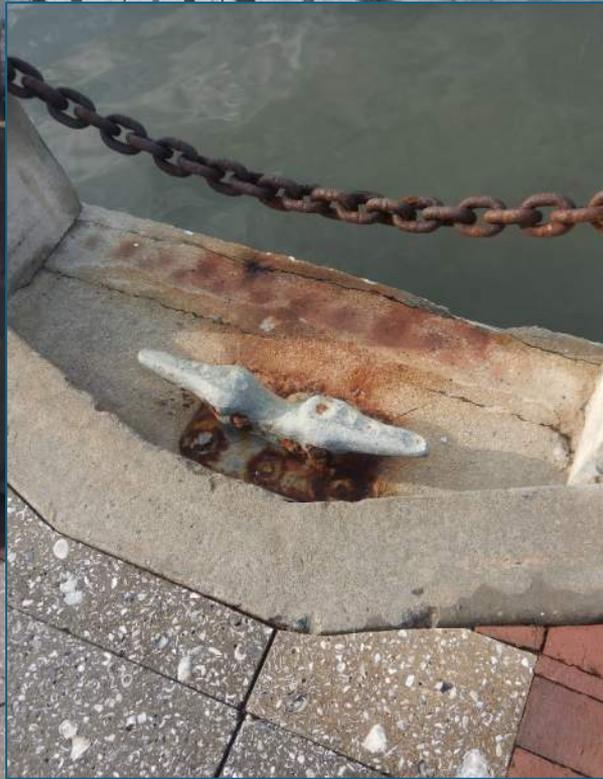
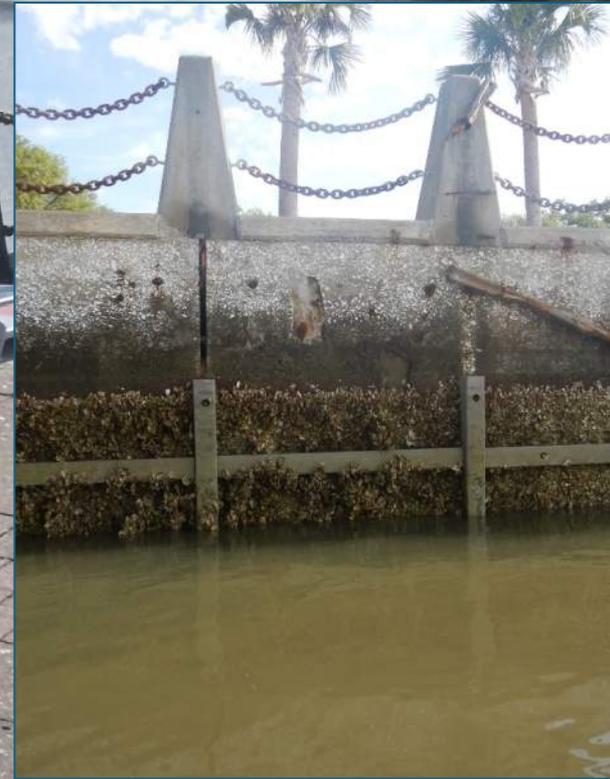
- **MINOR TO MODERATE WEATHERING AND DETERIORATION ABOVE THE WATERLINE**
- **MISSING TIMBER FENDER ELEMENTS (RUB RACK), 40 TO 50 PERCENT**

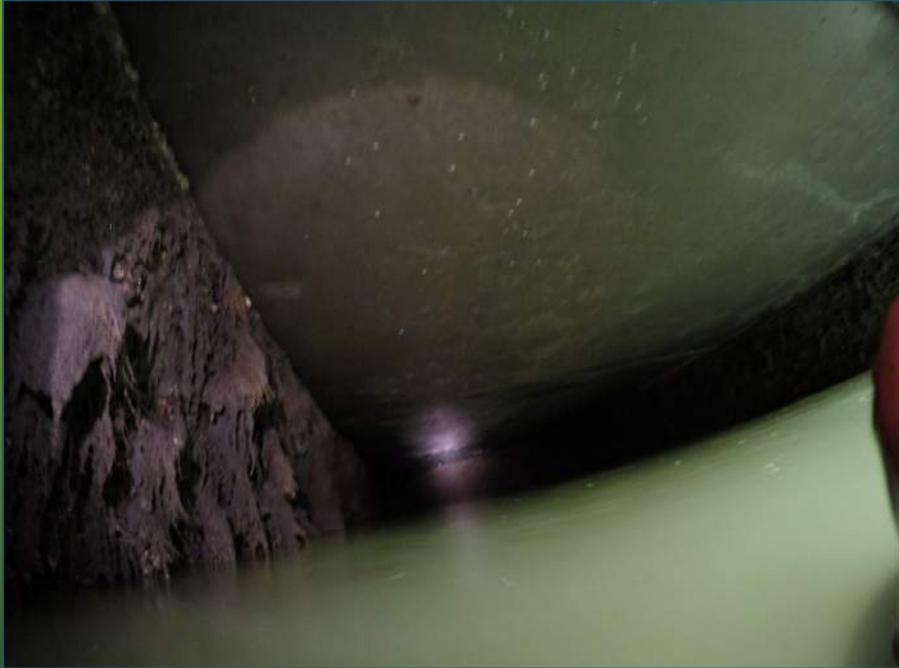
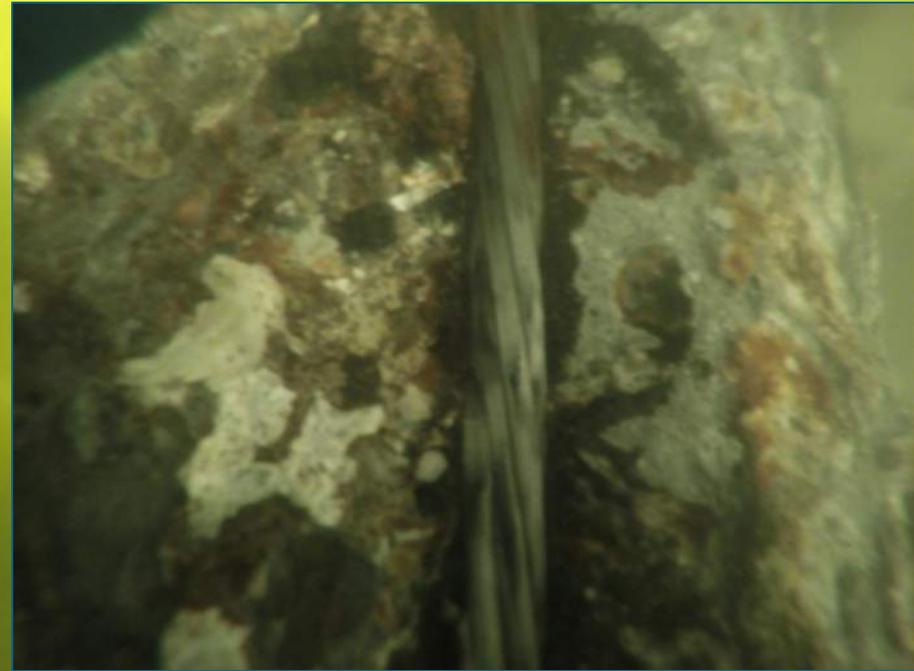
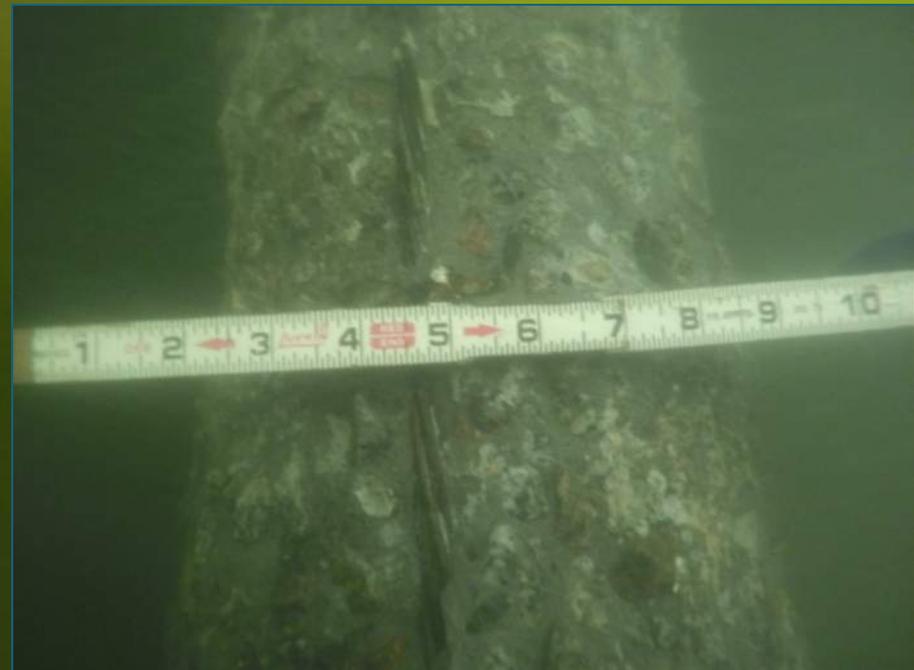
- **CAPS AND DECK IN FAIR CONDITION**
- **EXTENSIVE SHOALING**
- **PILE DETERIORATION**
  - **SOFT CONCRETE**
  - **EXPOSED REINFORCING STEEL**
  - **ROUNDED EDGES**
  - **BROKEN**

- **INCREASE INSPECTION FREQUENCY**
- **RESTRICT COMMERCIAL VESSEL USE UNTIL:**
  - **STRUCTURAL AND MOORING ANALYSIS INDICATES OTHERWISE**
  - **AUXILIARY MOORING STRUCTURES ARE INSTALLED**
- **INITIATE PRELIMINARY STUDIES AND SECURE FUNDING FOR REPLACEMENT OF THE STRUCTURE**
- **INSTALL PILE JACKETS ON DETERIORATED PILES**

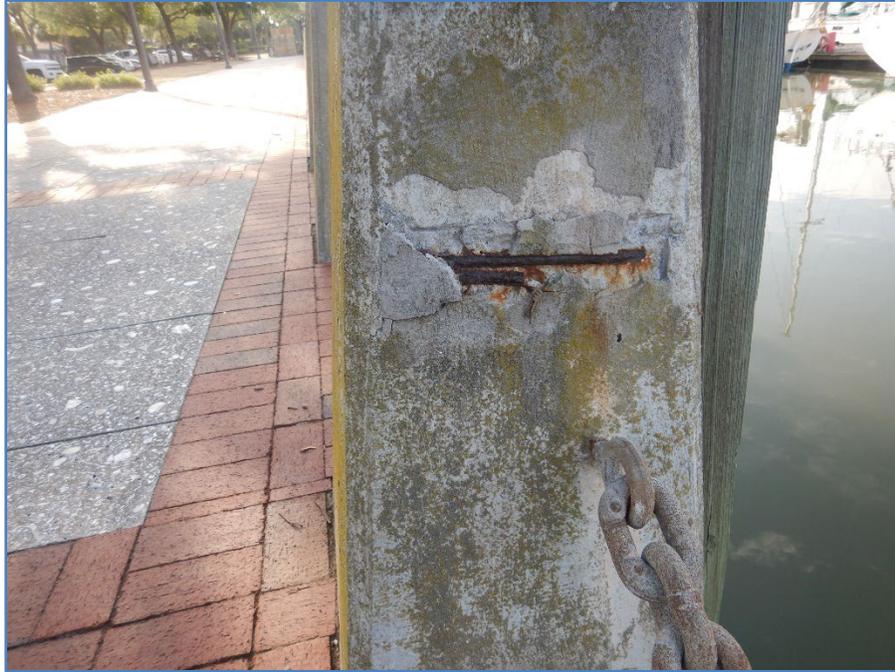
Photograph 3: Typical Intermittent Spall with Exposed Reinforcing Steel

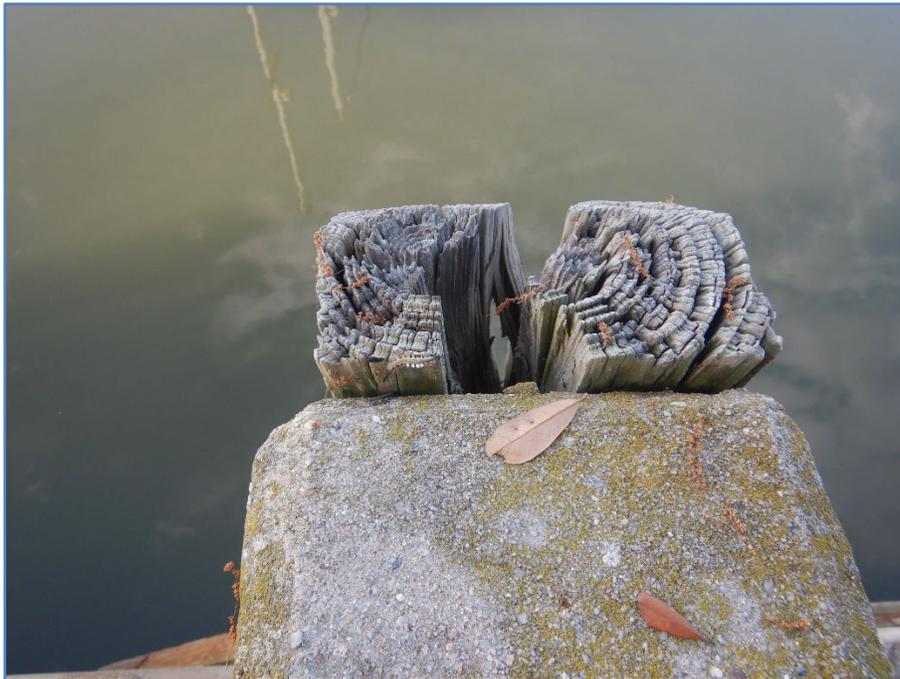
The timber rub rack consists horizontal and vertical timber wales bolted to the outboard side of the Relieving Platform. The lower portion of the rub rack consists of composite (plastic) 6x6 fenders with stainless steel hardware which were in good condition. The upper two-thirds of the rub rack assembly consists of 6x6 timber fenders. Approximately 40 to 50 percent of these fenders were missing. Most of the remaining timber fender elements were weathered or heavily deteriorated. The connection hardware for these elements was severely corroded.

Photograph 4: Typical Rub Rack Condition Above the Waterline

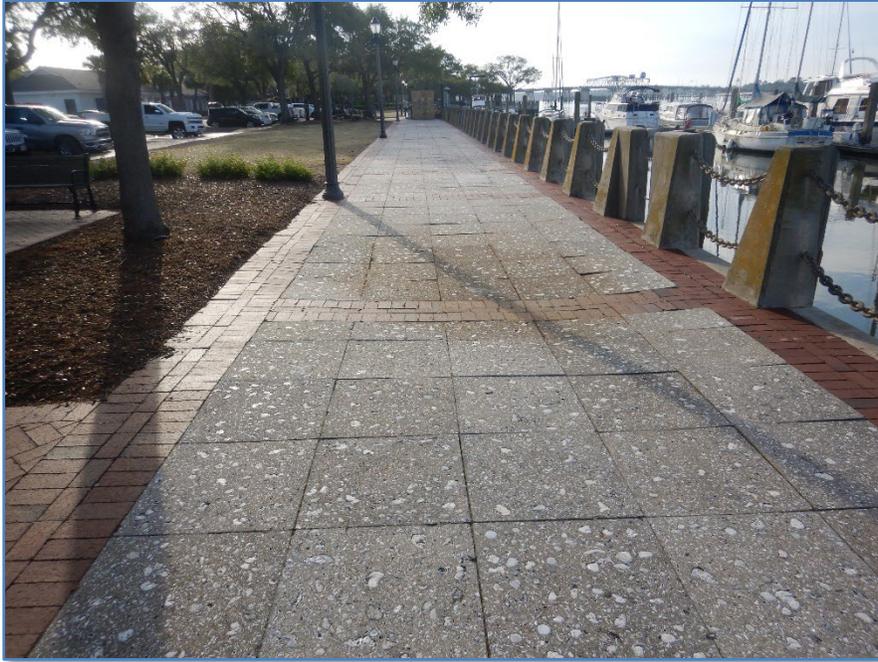
Along the length of the seawall, but most predominantly located at the western end, separations between adjacent sheet piles were evident. The separations are at the locations where the trapezoidal “key” forms the tongue and groove component of the prestressed concrete sheet pile. The separations between sheets were a maximum of 2-in. Depressions in the brick promenade, likely due to loss of backfill at the separated joints, were evident throughout. However, no active sinkholes were noted.

Photograph 5: Typical Sinkhole Behind Seawall

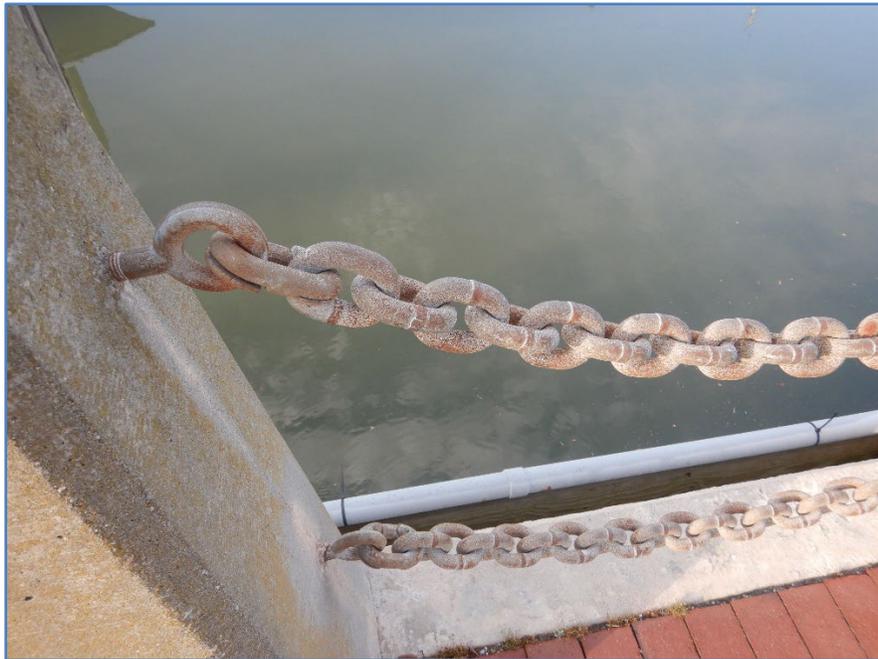
Photograph 6: Typical Chain Condition

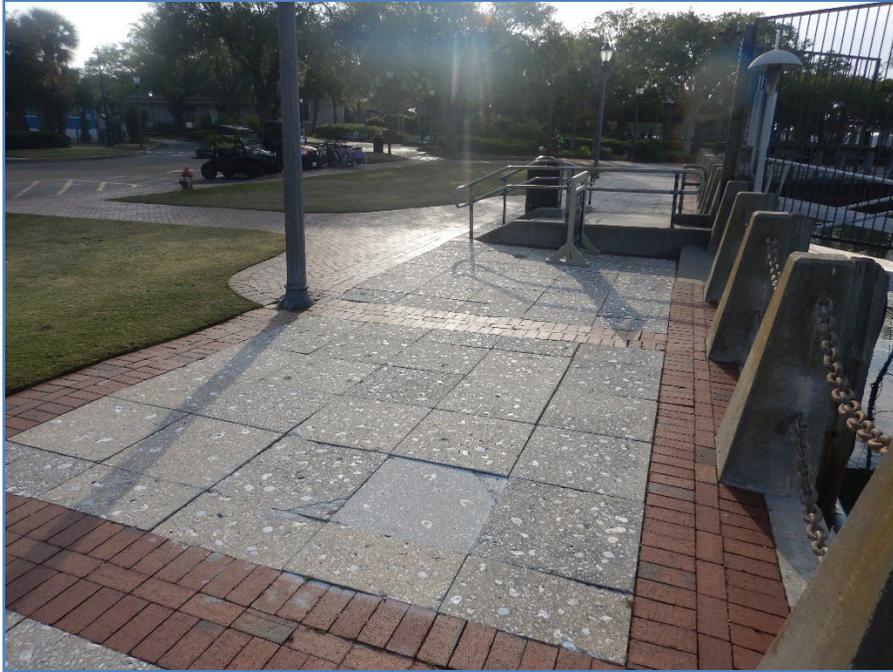
Photograph 7: Typical Sinkhole

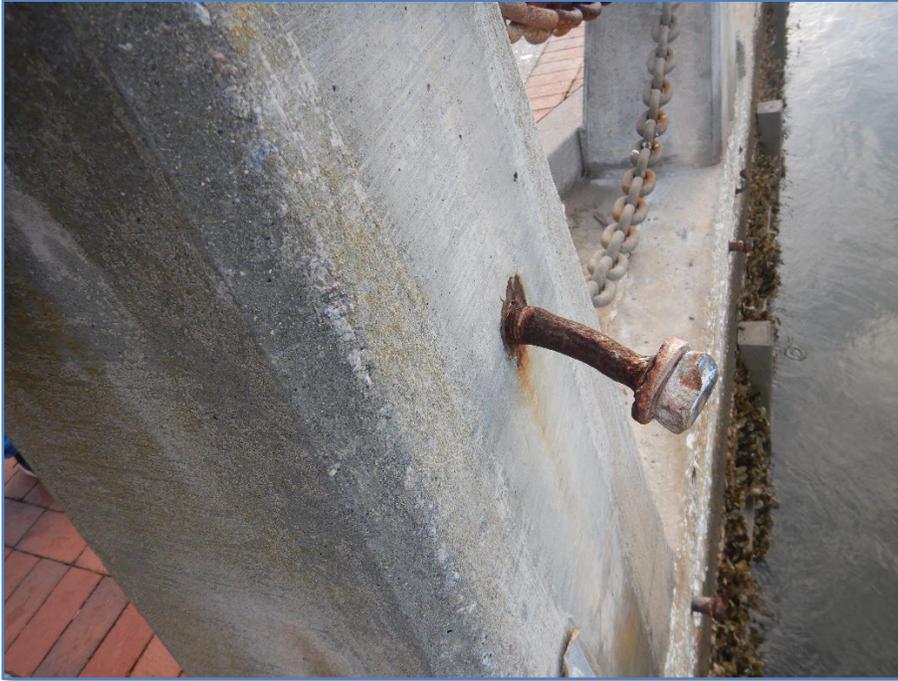
Photograph 11: Typical Hardware with Severe Corrosion and Missing Fascia Board

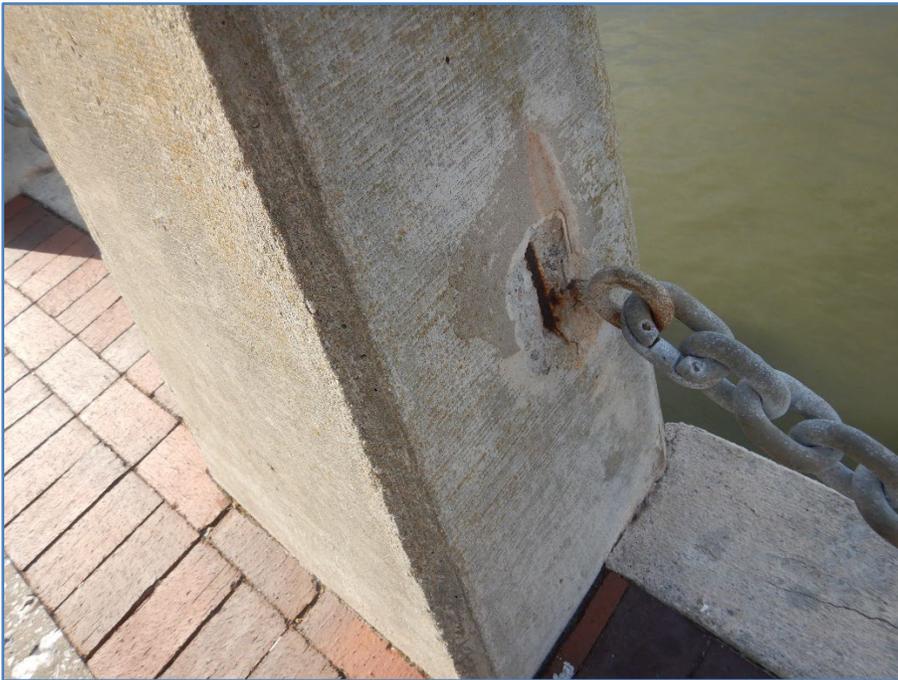
Photograph 12: Typical Spalling at Chain Connection with Exposed Reinforcement

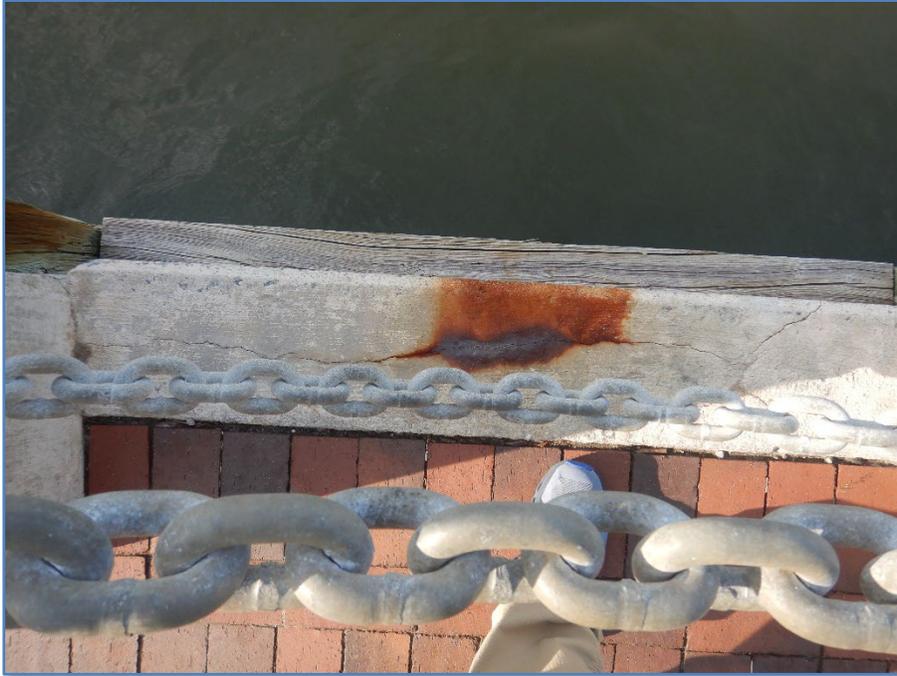
The precast concrete fascia panels exhibited moderate deterioration in the form of cracks up to 1/4-in. wide with rust staining, an indication that the internal reinforcing steel is corroded.

Photograph 13: Typical Rust Staining at Top of Fascia Curb

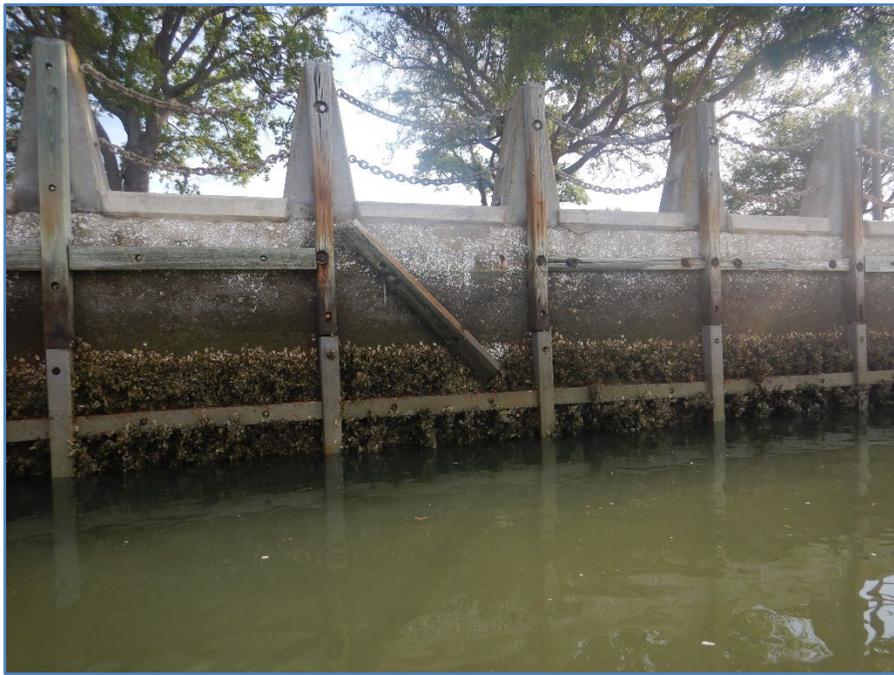
Photograph 14: Disconnected Rub Rail

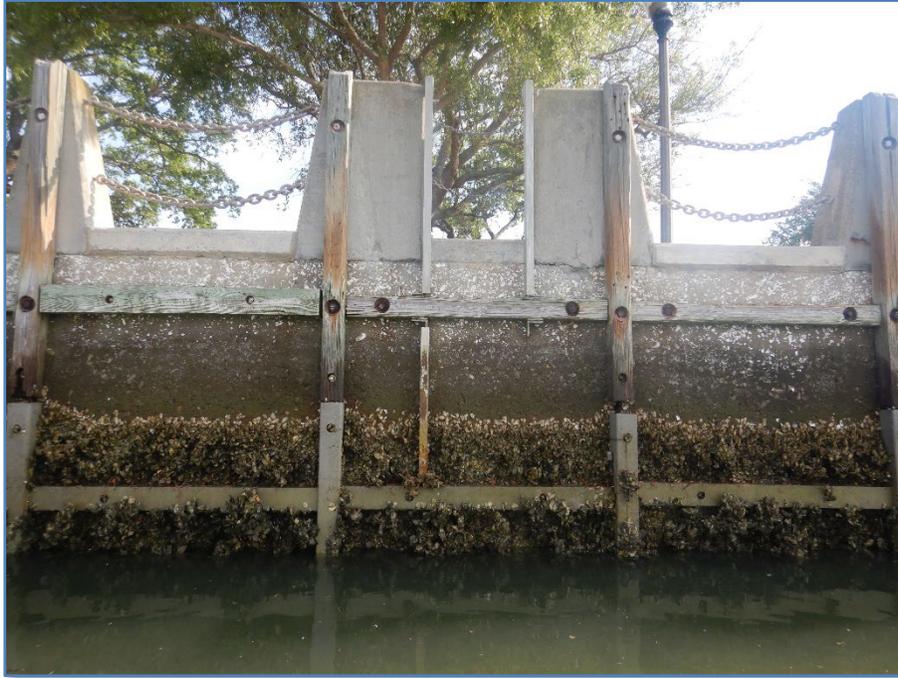
Photograph 15: Broken Swim Ladder

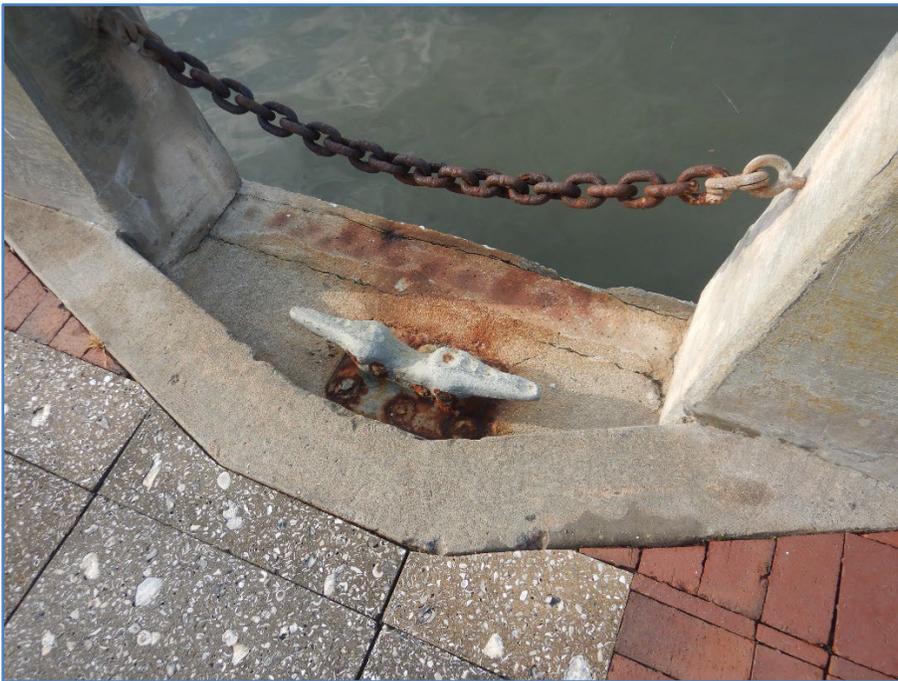
Photograph 16: Typical Cleat Corrosion

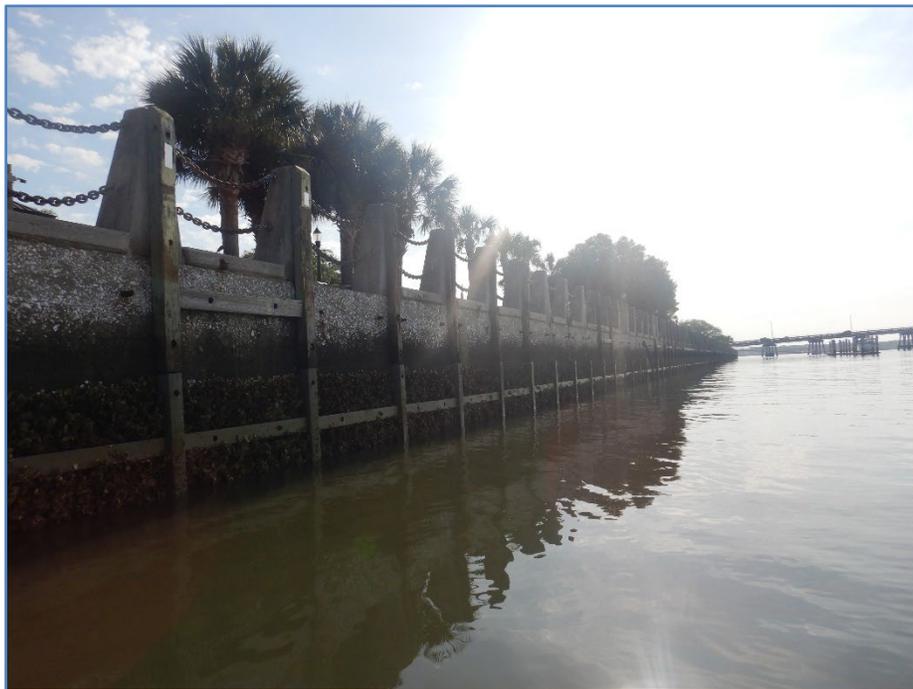
Photograph 18: Approximately 50% Missing Rub Rail

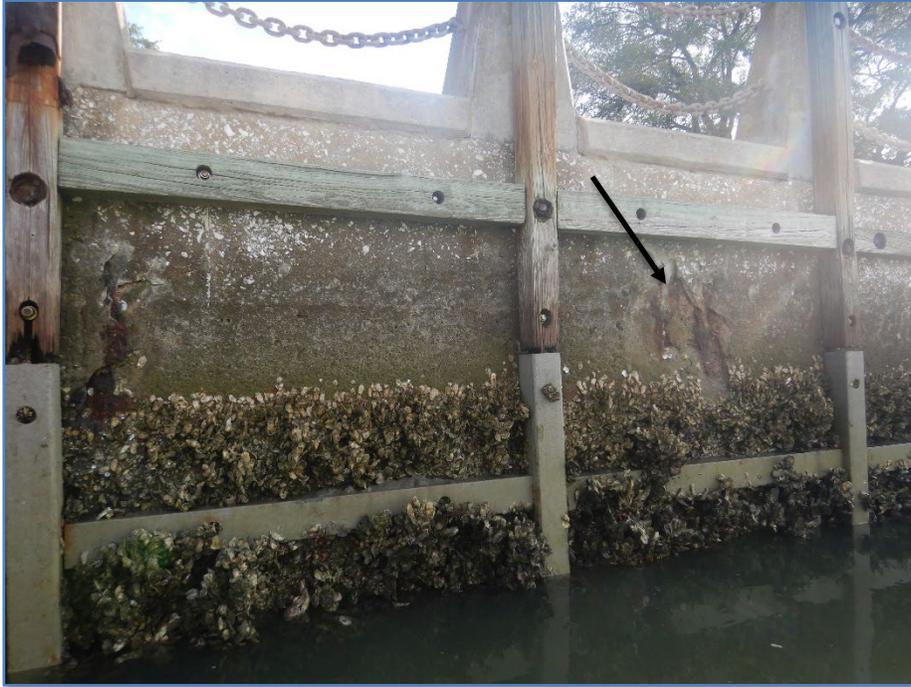
Photograph 19: Typical Seawall Spall

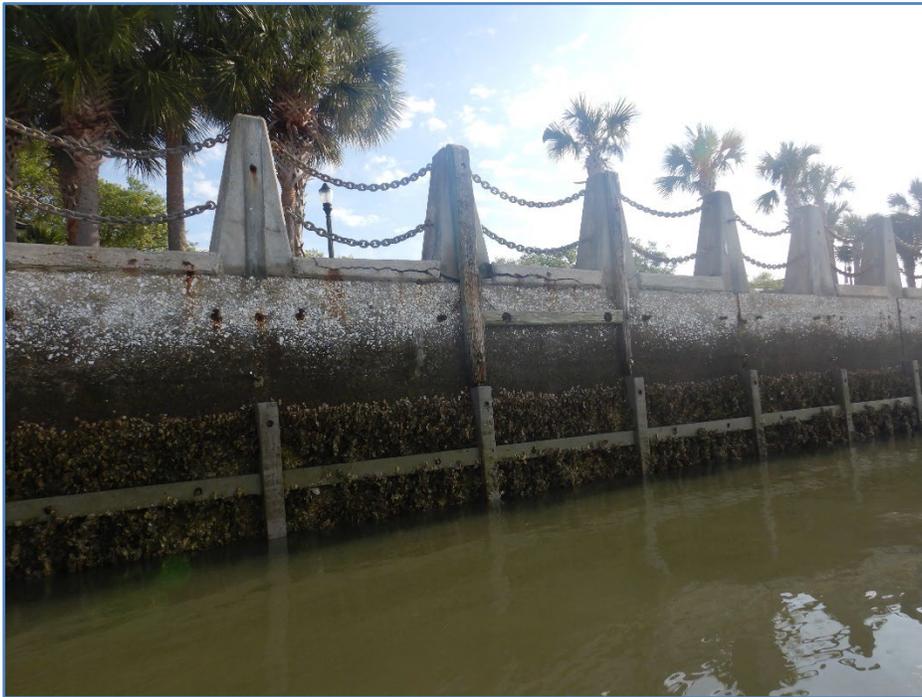
Photograph 20: Typical Horizontal Cracking in Fascia Curb

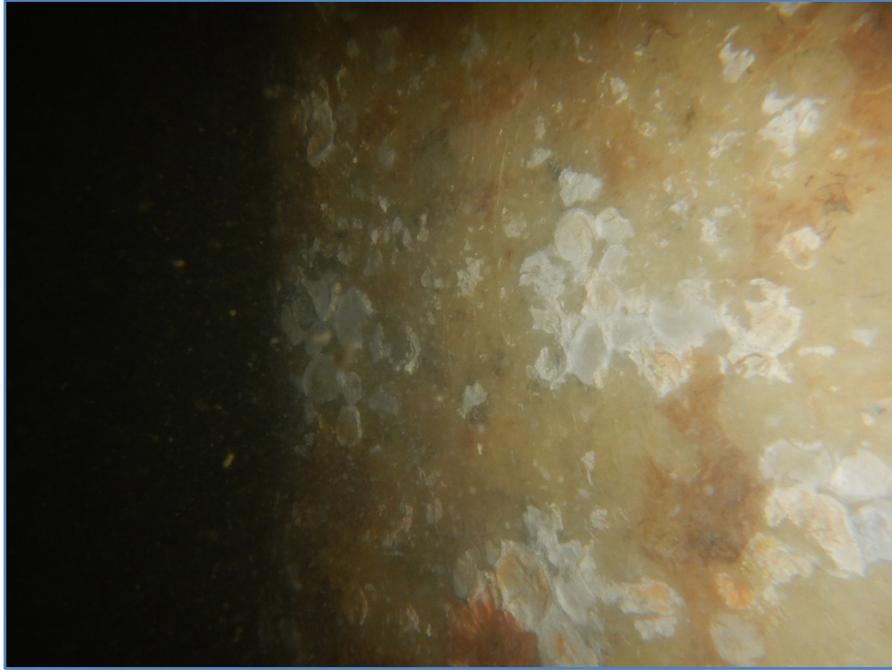
An assessment of the pile encasements installed during the 2018 and 2019 repair projects indicated that they are intact. Slight undermining of the epoxy bottom seal was noted in isolated locations; however, not at penetrations deep enough to reach the original pile.

The 47 pile encasements appear to be serving as intended: to preserve the remaining capacity of the piles at the time the encasements were installed. Each encasement extends from the bottom of the pile cap to just below the channel bottom. It is important to note that while the encasements have extended the life of the pile, we have no understanding of the level of pile deterioration below the encasement where the pile enters the mudline. Given the ongoing conditions encountered during multiple inspections, it is entirely possible that the piles below the jacket/mudline have severe deterioration. In addition, given the high chloride content of the piles, it is possible that pile reinforcement is continuing to corrode, even inside the encasements.

Photograph 21: Typical Underwater Pile With Jacket

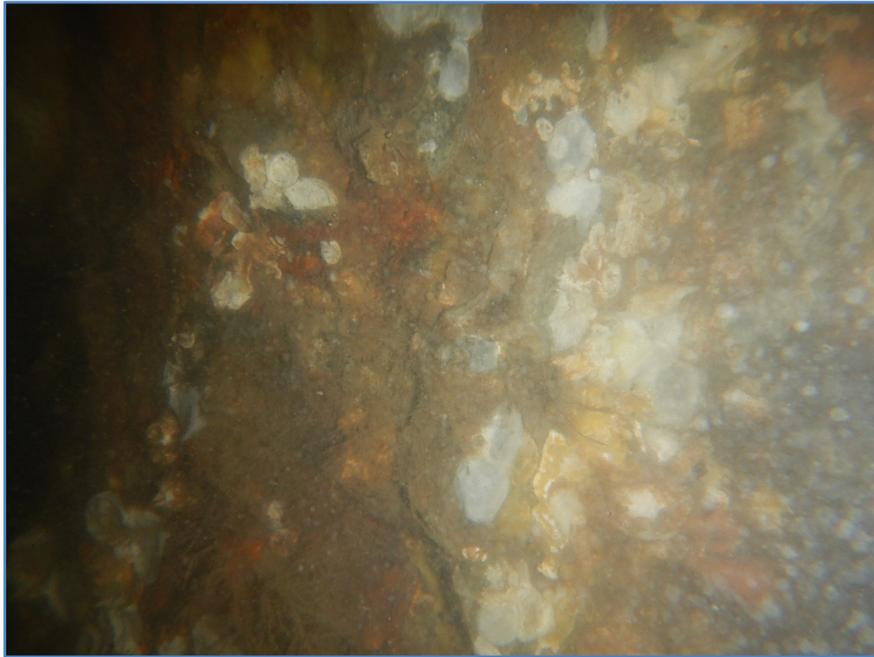
concentration and its ability to accelerate corrosion, as evidenced by the complete breakdown of internal reinforcing steel at some pile locations. These conditions, combined with the near 50-year age of the pilings, has led to the severe and continual deterioration of the foundation elements.

Photograph 22: Typical Underwater Concrete Pile Condition

1. Increase inspection frequency to intervals not to exceed 48 months.
2. Restrict commercial cruise vessels from mooring against the structure until:
  - a. a complete structural and mooring analysis indicates otherwise.
  - OR
  - b. auxiliary mooring structures are installed. Auxiliary structures may consist of pile supported breasting and mooring structures placed independently of the Relieving Platform.
3. Initiate preliminary studies and secure funding to begin replacement of the structure.
4. Install pile encasements on piles exhibiting deterioration.
