THE BEAUFORT PRESERVATION MANUAL

prepared for the
CITY of BEAUFORT
BEAUFORT, SOUTH CAROLINA

JOHN MILNER ARCHITECTS, INC.
Adopted November 15, 2022

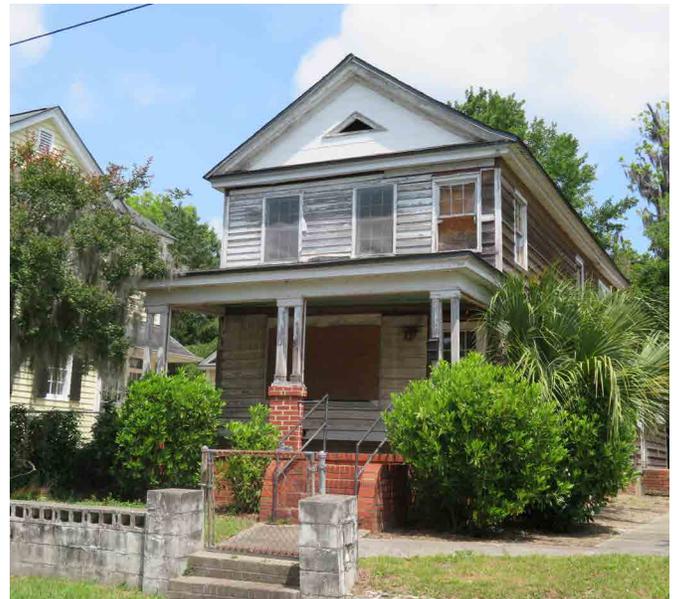
811 King Street. Porch steps should not typically be built of brick, but the cheek walls and metal railings in this example emphasize the incongruity.

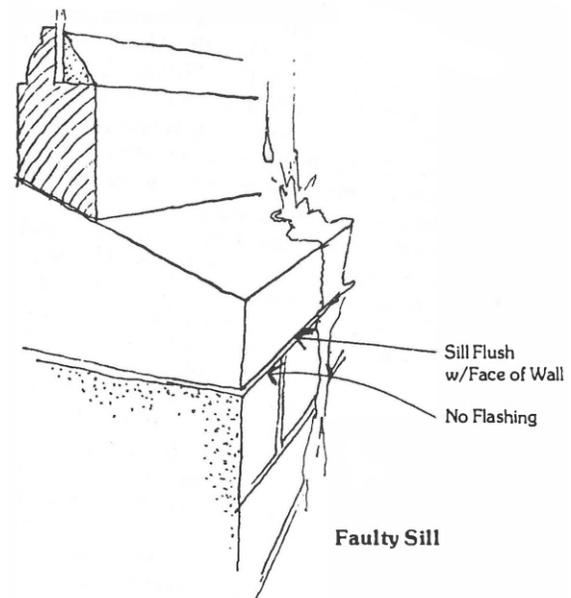
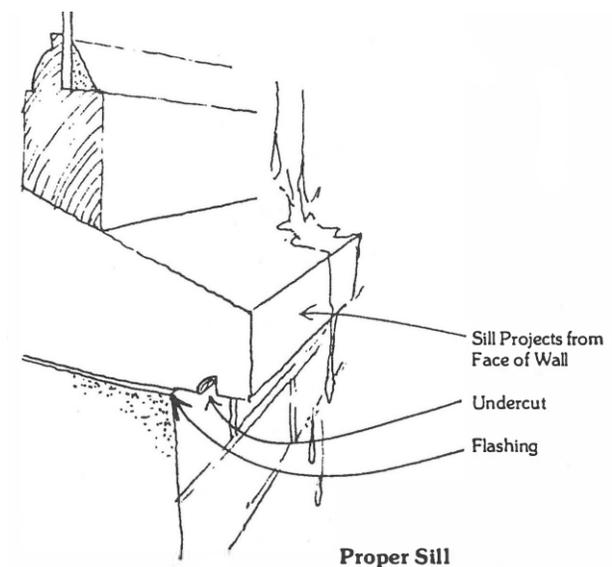
Faulty Gutters and Downspouts

the sill is flawed and water is entering the wall at this point.

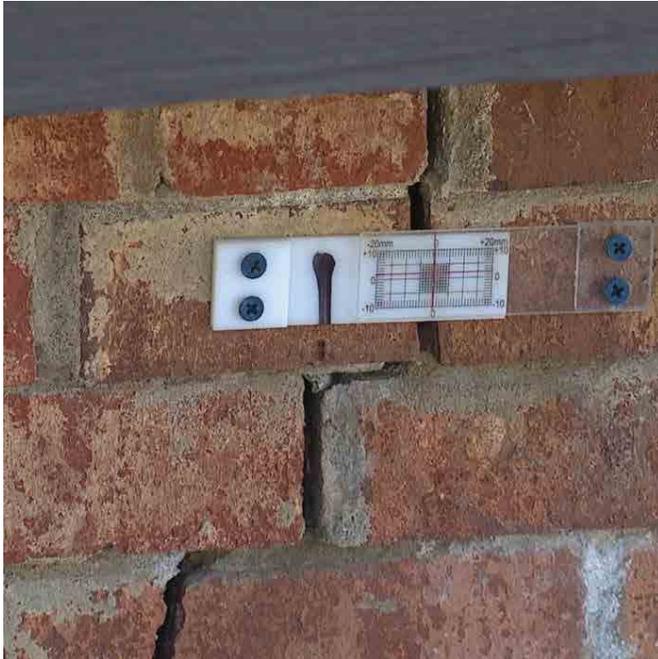
Crack Gauge

Cracks in masonry may be caused by both cyclical and non-cyclical movement in the building structure. Cyclical cracks occur due to the expansion and contraction of building components relative to one another caused by daily and seasonal changes in temperature and humidity. Such cracks are often observed at the joint between a historic structure and a later addition and at corners where opposing walls push against one another. Non-cyclical cracks occur at areas of differential settlement, ice jacking or deterioration of underlying structural timber or embedded metal. While minor cracking is to be expected after years of expansion and contraction and small structural movements, the appearance of new cracks or the widening or lengthening of existing cracks should be cause for investigation. The placement and monitoring of an inexpensive crack gauge (shown below) or other tell-tale over a period of months or change in seasons may be helpful in assessing whether a crack is due to cyclical movement or a progressive movement that might be cause for concern.

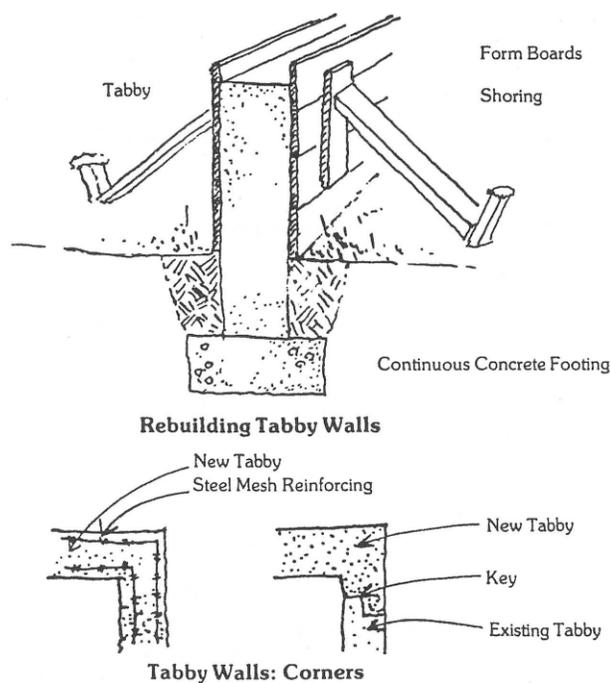
The reconstruction of entire sections of wall is very similar to the historical process of building tabby. Horizontal form boards are used into which pours are made in layers. If the tabby is to remain exposed, the thickness of the layers and placement of peg holes should match that of the existing material. If not, then layers 6-10 inches thick, tamped frequently during placement, should suffice. Two to three days after the pour, the forms are removed. The exposed face of the new wall section is then brushed with water and a fiber bristle brush to bring out the shell texture and provide a key for stucco. Several precautions will help to insure structural stability. New walls can be set onto continuous spread footings while existing, settled walls can be underpinned (see “Brick”); in either case the advice of a competent structural engineer is essential. New corners should be reinforced with steel mesh, and where old corners meet with new material, a “key” should be cut in the old tabby.

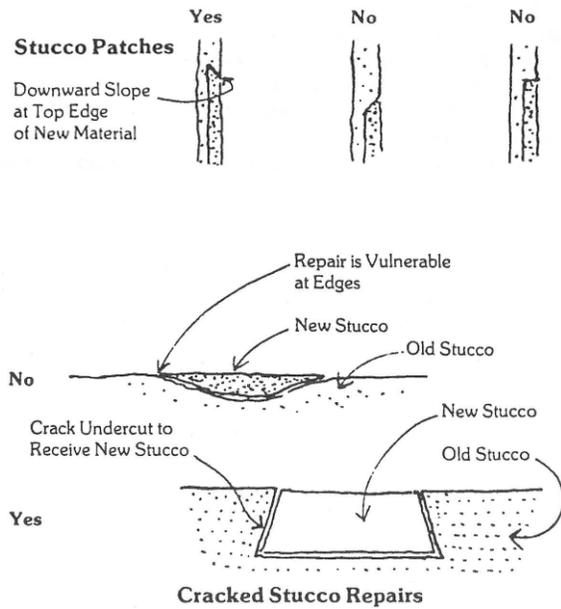
Proper preparation of stucco cracks for patching is critical to achieving a durable repair. Never install new stucco in a crack that has been merely grooved to receive it. Instead, existing stucco should be undercut to provide a “key” for receiving the new work. This is made by opening up the crack with a knife or small diameter grinding wheel and undercutting the edges. Horizontal cracks, along with the top edge of vertical cracks, should be undercut so that no seam between existing and new construction will lead downward into the building.

After the undercut has been made, brush out all loose material. Then, moisten the crack and fill it with a stucco that matches the adjacent material. The stucco is applied with a trowel or a putty knife and should fill the crack tightly and completely. In fact, it should slightly overfill the edges of the crack. After it has set for fifteen minutes, the stucco can be troweled flush with adjacent areas. It should then be “cured” for three or four days, during which time the repaired area is moistened daily, both in the early morning and late afternoon. Successful patch recipes will weather to match the original material over time. When a proper recipe has been determined for a given structure, it should be preserved for future repairs.

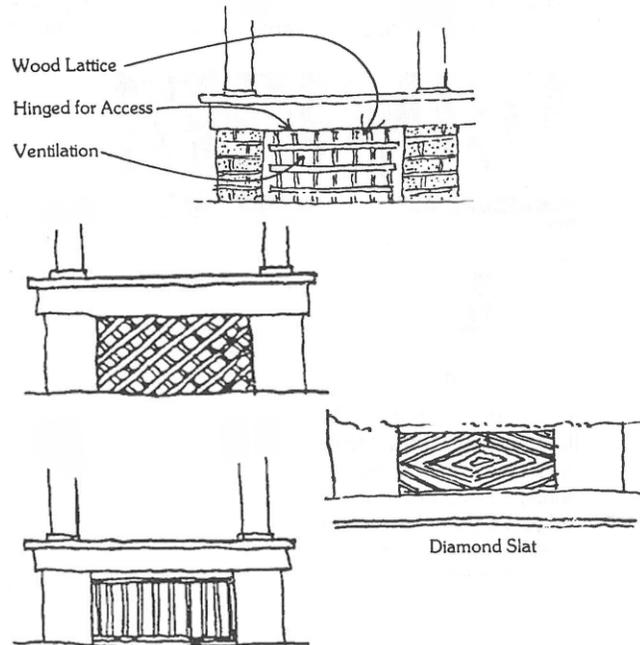
Appropriate Lattice Infill At Foundation Piers

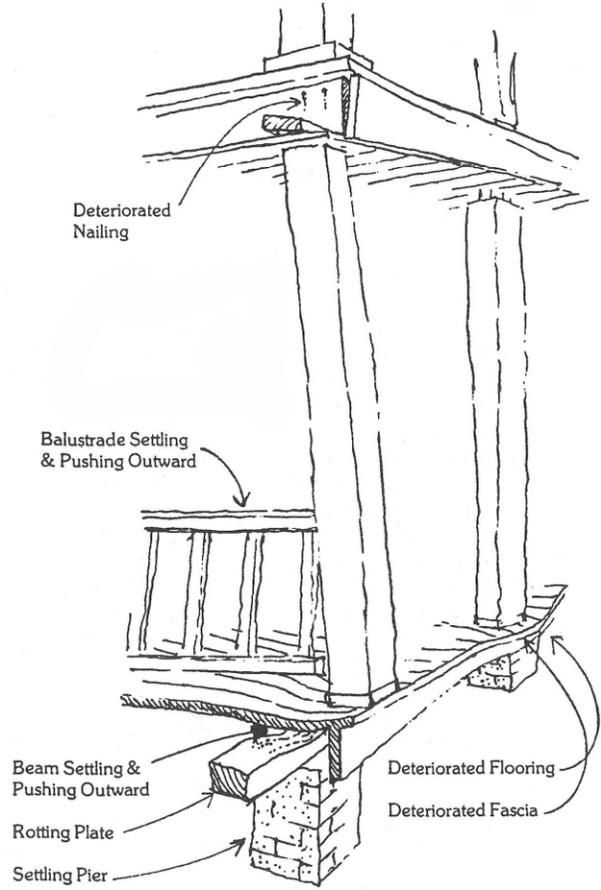
Leaning/Rotated Columns: Causes

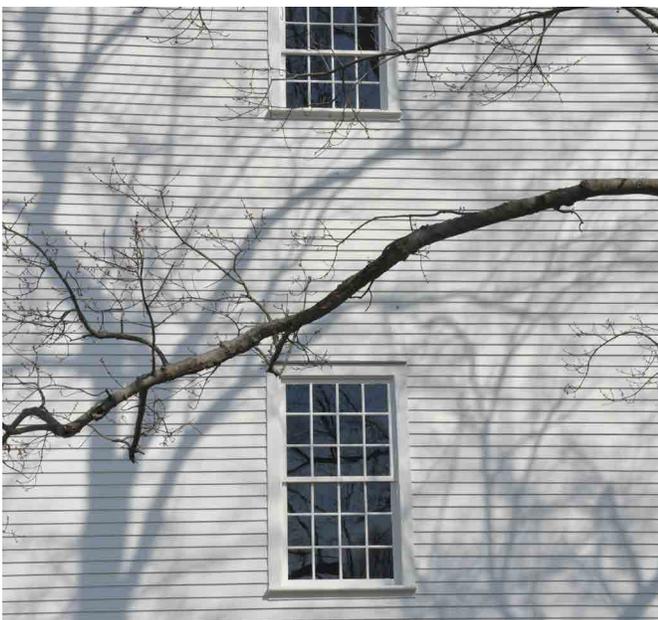
Example of Shadow Lines

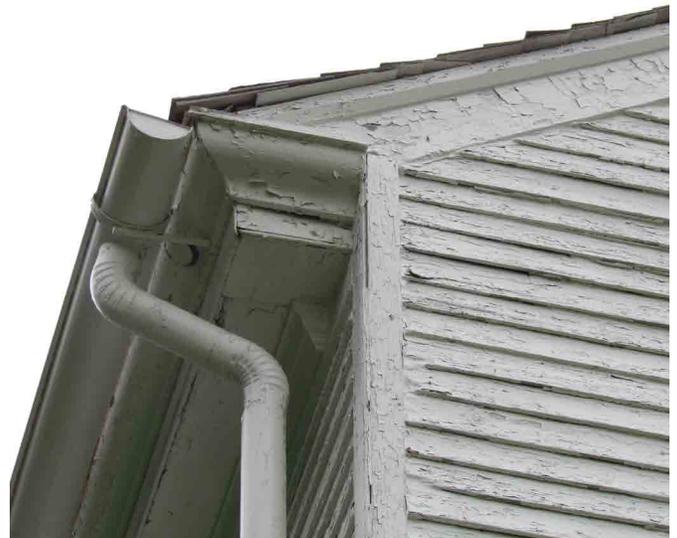
Example of Trim Sealing Vulnerable Locations

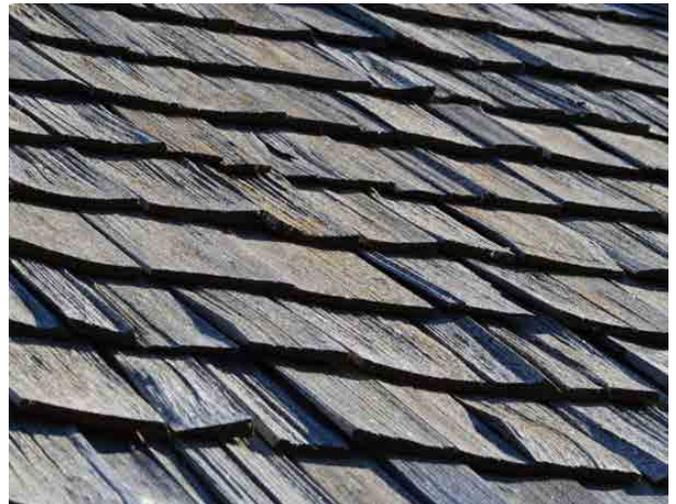
Cupping and splitting of wood shingles

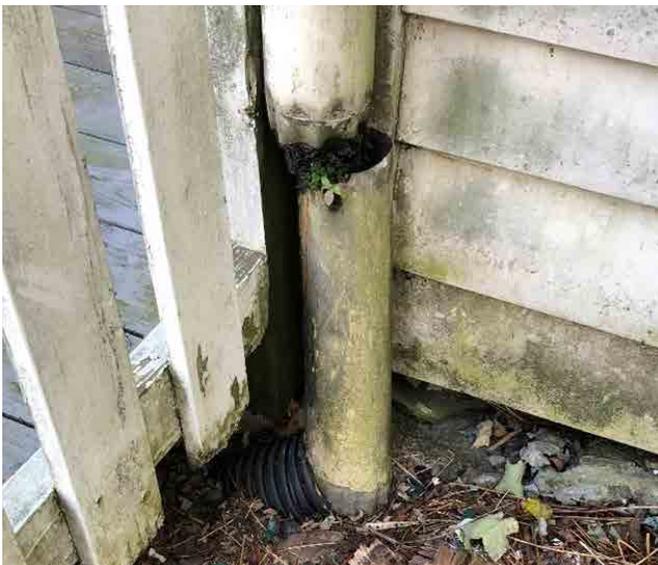
Leaking gutters and broken downspouts allow water to penetrate vulnerable wood structures and masonry foundations

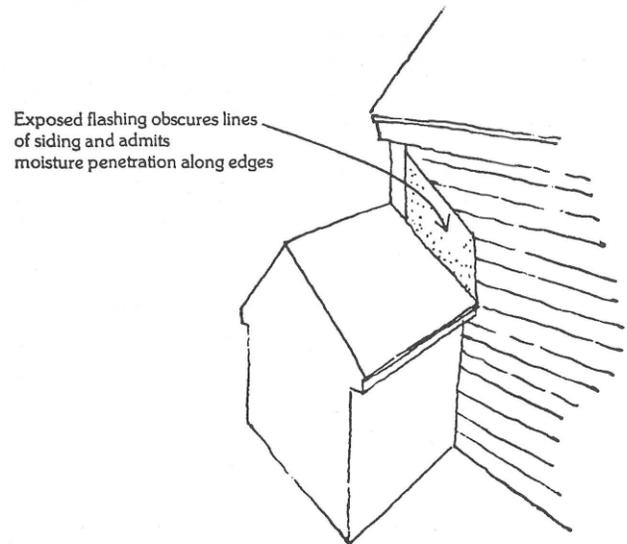
Inappropriate Flashing Installation

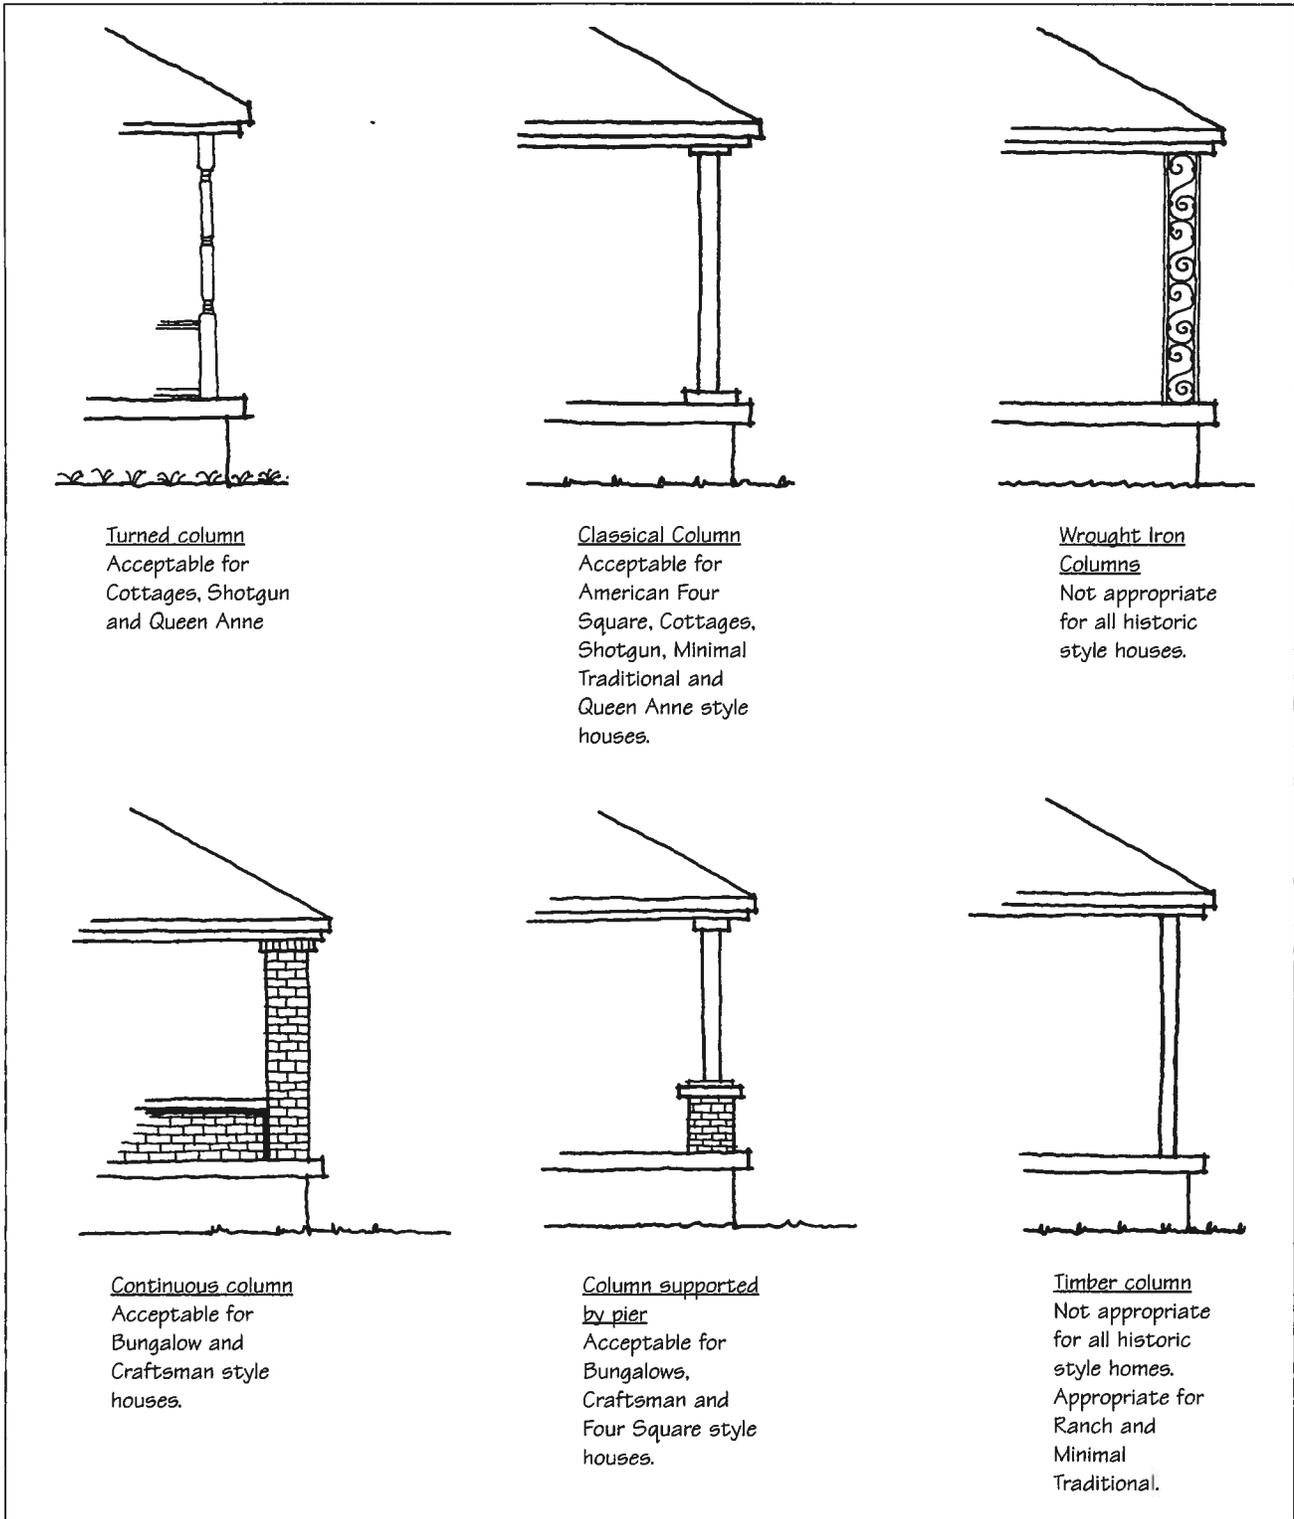
A variety of column styles, illustrated above, are found throughout the Northwest Quadrant. Specific column styles compliment building types. For example, turned columns are mostly found on Vernacular cottages. Consider using the appropriate column style when restoring a porch.

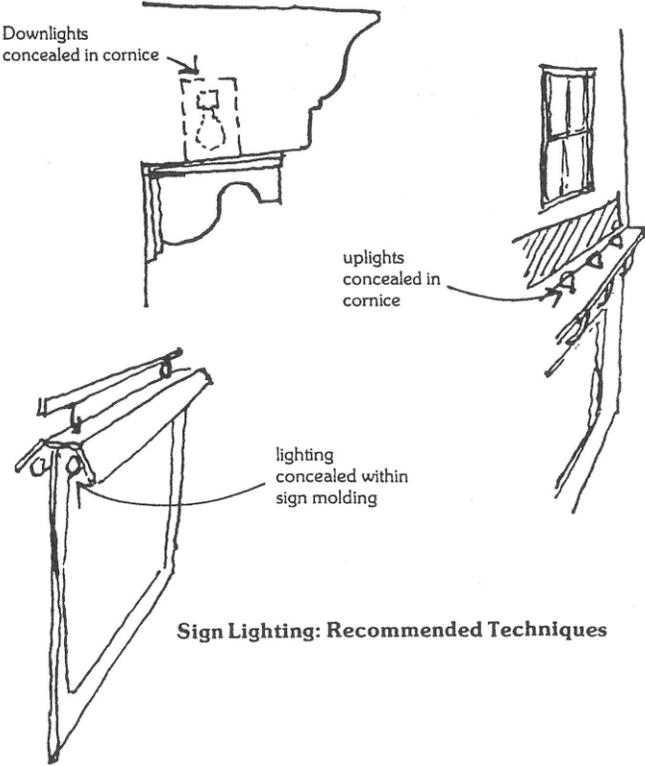
Sign Lighting: Recommended Techniques
