**BEAUFORT COUNTY
HISTORIC SITES SURVEY - 1997**

CITY OF BEAUFORT
Historic District Review
Board Full Board
Staff Report
Meeting of August 13, 2014

Case Number: HR14-36
Property Address: 1407 Duke Street
Applicant: Historic Beaufort Foundation
Type of Request: Alterations and Additions - Final
Zoning: GC – General Commercial (NWQ)

FROGMORE LODGE

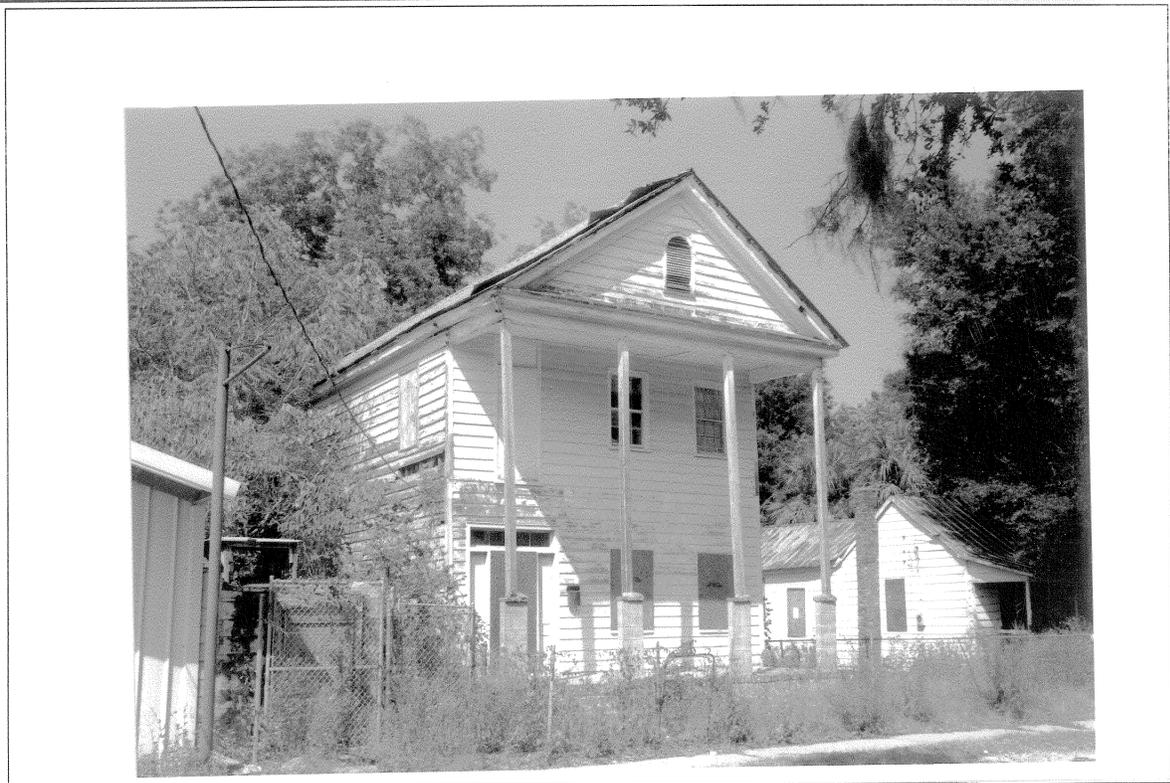
Photograph:

Roll # Neg. View of:
S-13 23 S facade & W elev., fac. NE

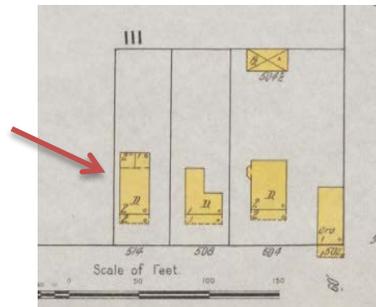
Historic Sites Survey as “Contributing to the listed district.” It’s estimated that this building is c.1870 and is the former Frogmore Lodge. It first appears on 1912 Sanborn Map (left). There was a substantial porch alteration c. 1940 that replaced the traditional double stacked porch, as indicated in the Sanborn Map, with a two-story exaggerated order porch.

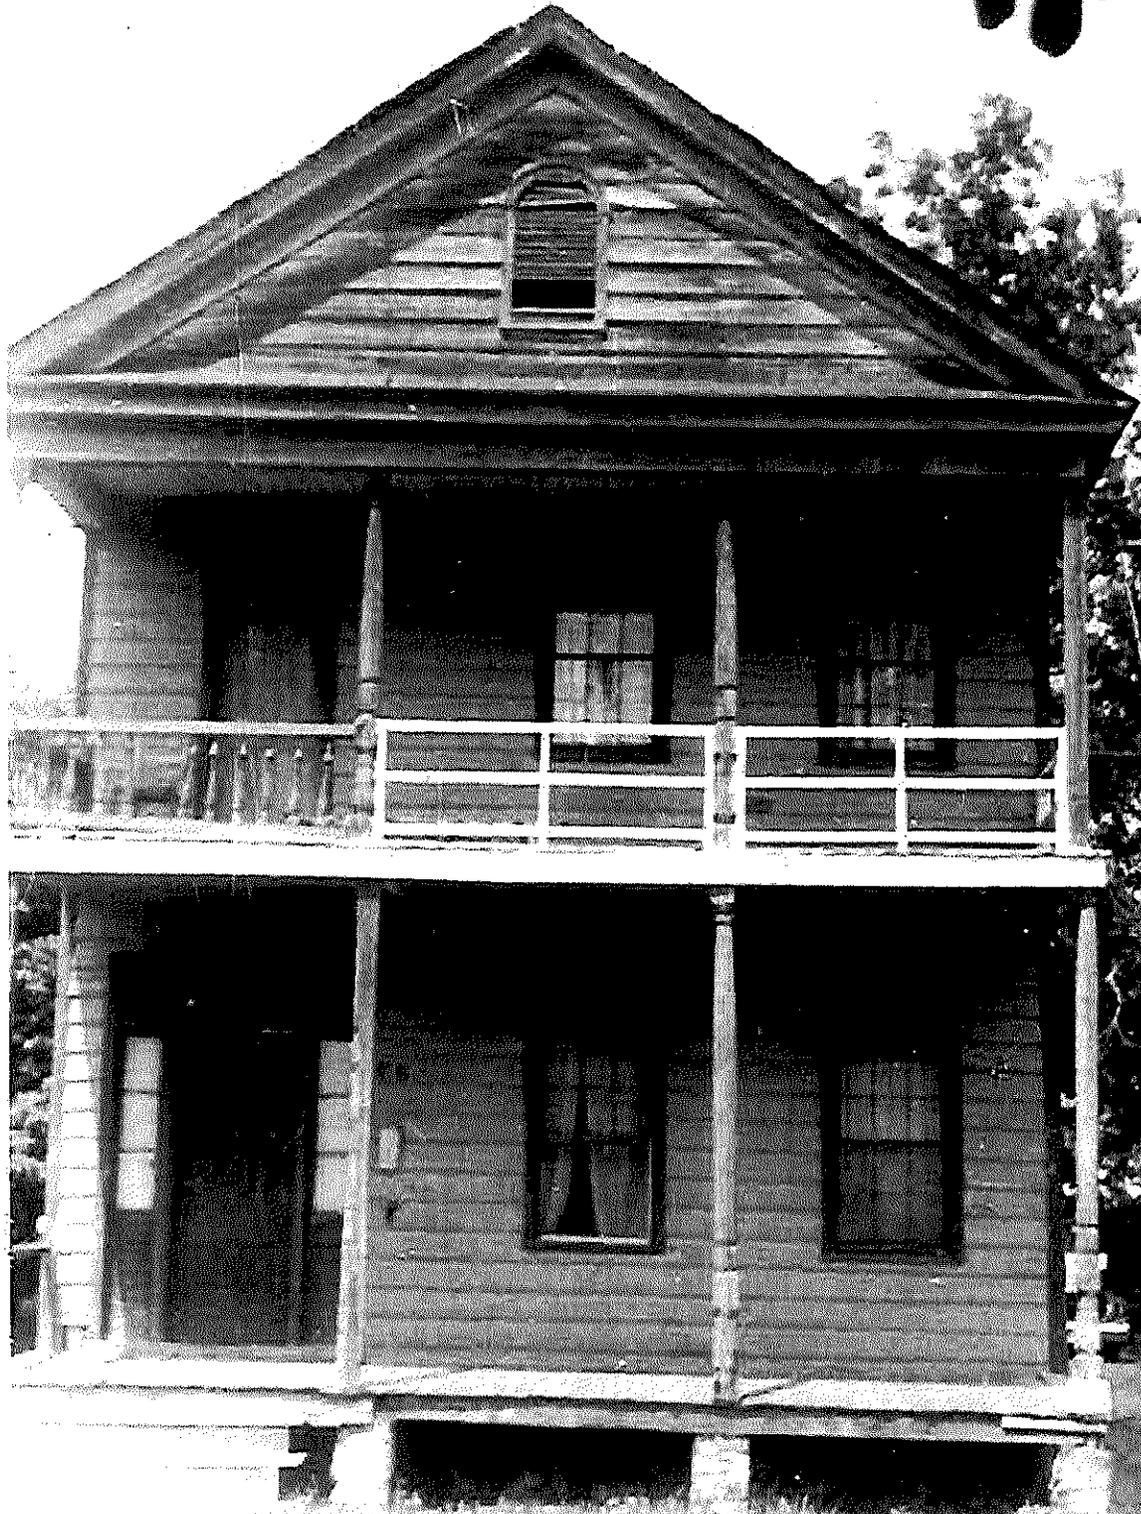
2-20-68

1407 DOKE

- **Reconstructing the front porch to a two-story, stacked porch, as is seen in the 1968 photograph;**
- **Removal of the dilapidated rear addition, and securing the rear opening with plywood.**
