SEACOAST PACKING COMPANY

THE PICKLE FACTORY
PLANNED UNIT DEVELOPMENT
BEAUFORT, SOUTH CAROLINA

December 8, 2006

Prepared by: **DAWSON WISSMACH** ARCHITECTS

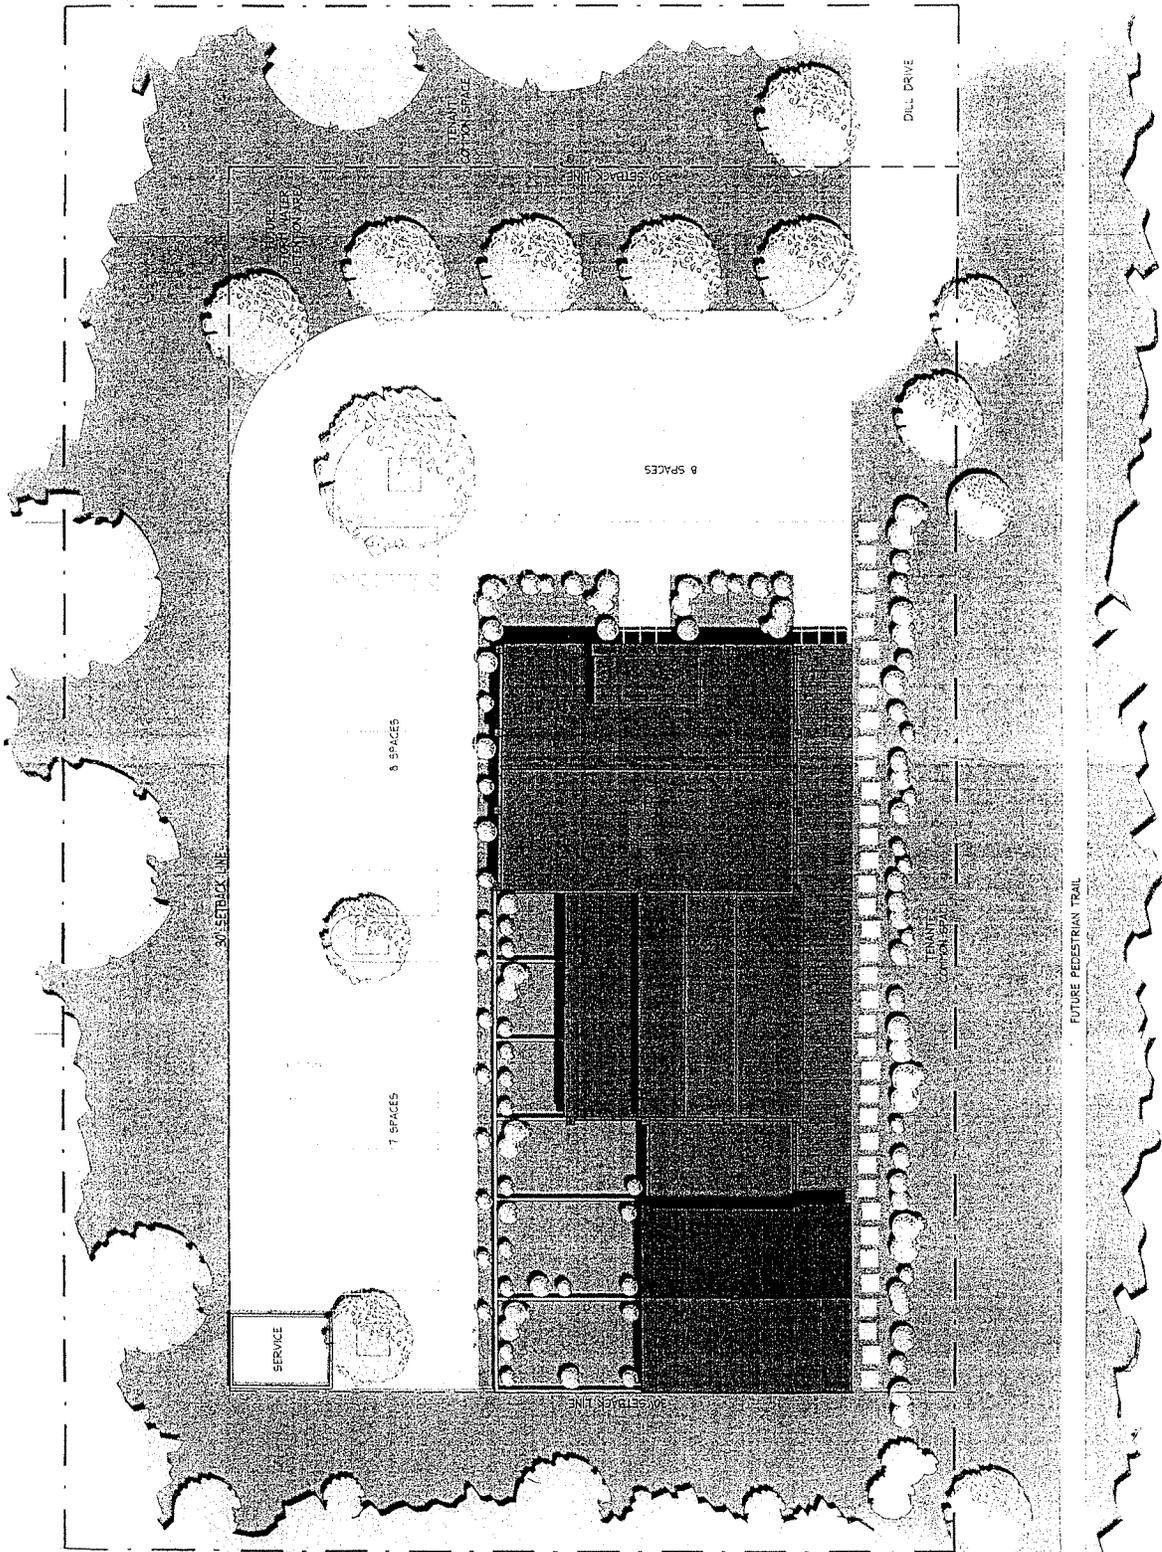
—2
SCALE 3/32" = 1'-0"

THE PICKLE FACTORY

The existing Pickle Factory building was constructed in 1920 as a livestock shipping facility for the Seacoast Packing Company. The building's structure was designed as a poured in place concrete frame with a structural tile wall infill system typical of the time period, but unique to the area. The building has been abandoned for almost half a century and has fallen into a state of serious disrepair. While the concrete structural frame is salvageable, a large amount of costly repair and replacement will be required to make the building habitable and to meet current code. Further information on the required structural repair can be referenced in the attached structural investigation report. The owner intends to restore the building exterior to its original character and design with in-kind replacement of all finished and new window systems. Additional exterior renovation work will include creating a new covered porch over the existing loading dock facing the railroad tracks. Small courtyards constructed of pervious material and natural landscaping are also proposed at the west side of the building. The interior will be renovated and adapted to accommodate (12) twelve residential units.

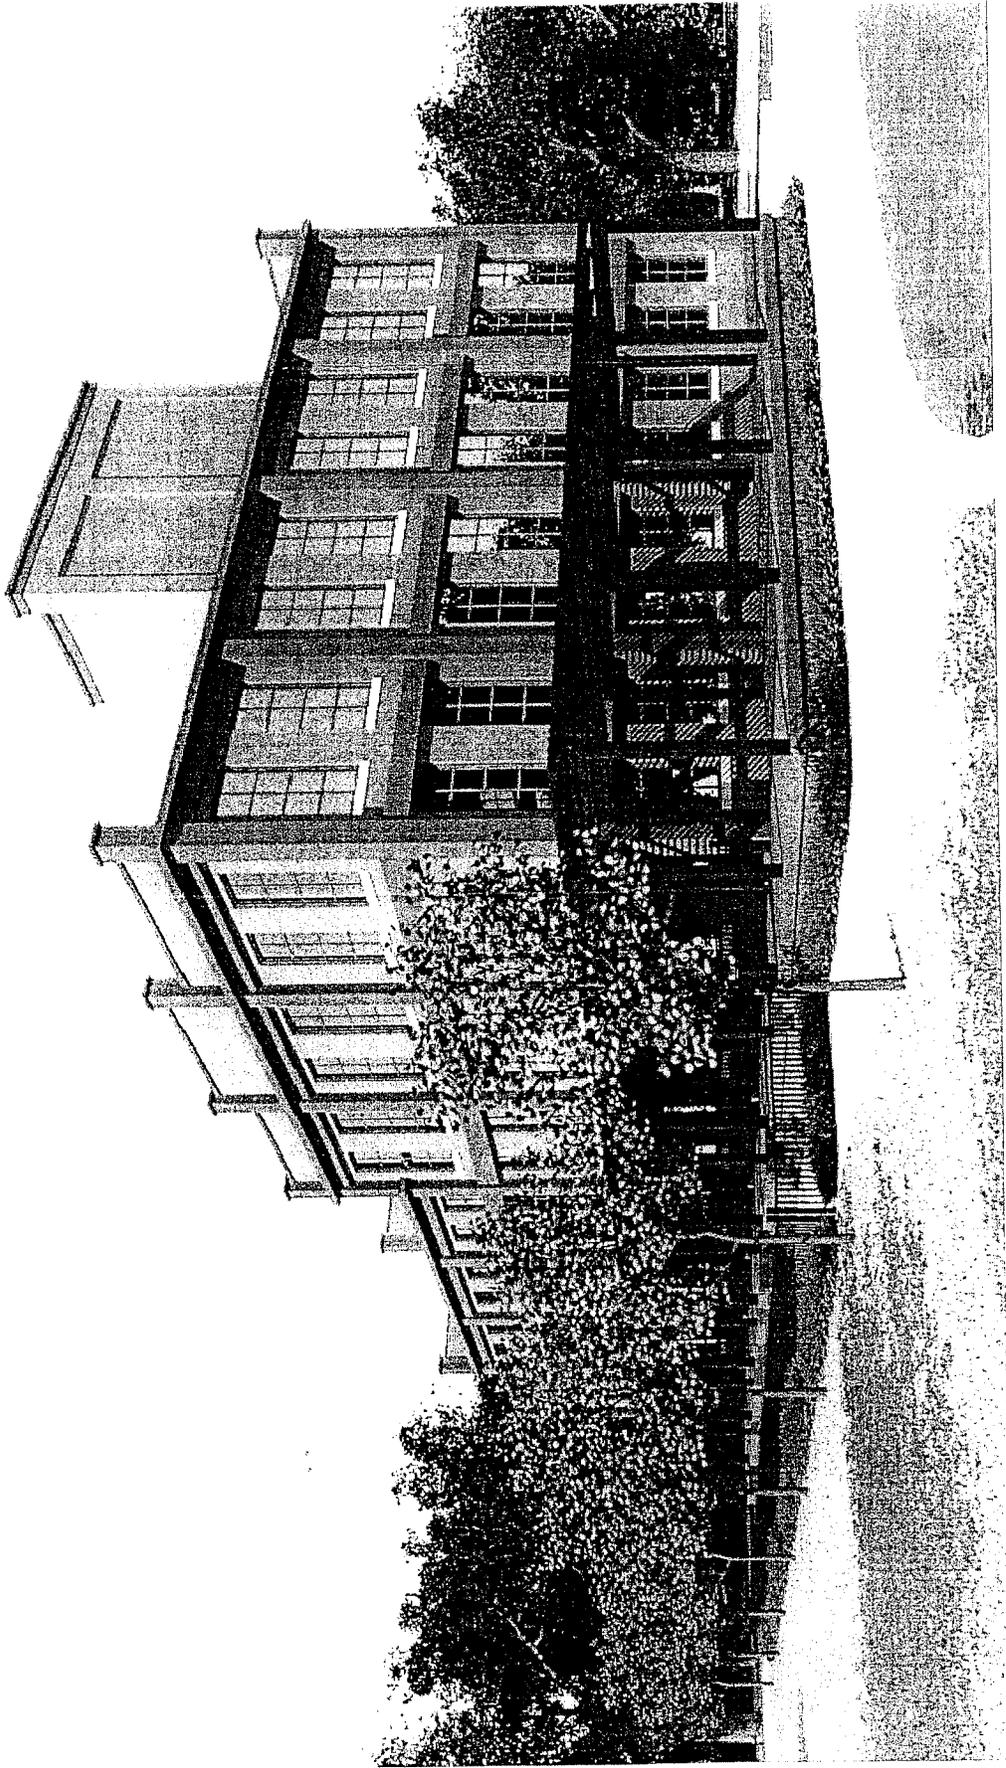
STREET PERSPECTIVE 1

THE PICKLE FACTORY
