**CITY OF BEAUFORT**  
**Historic District Review Board**  
**Full Board**  
**Staff Report**  
**Meeting of April 8, 2015**

**Case Number:** HR15-08  
**Property Address:** 804 Carteret Street  
**Applicant:** Christopher Cook for Luisa Meshekoff  
**Type of Request:** Alterations & Additions  
**Zoning:** OC – Office Commercial

**CITY OF BEAUFORT**  
**Historic District Review Board**  
**Full Board**  
**Staff Report**  
**Meeting of May 14, 2014**

**Case Number:** HR14-22  
**Property Address:** 804 Carteret Street  
**Applicant:** Luisa Meshekoff  
**Type of Request:** Alterations & Additions – Post Facto  
**Zoning:** OC – Office Commercial

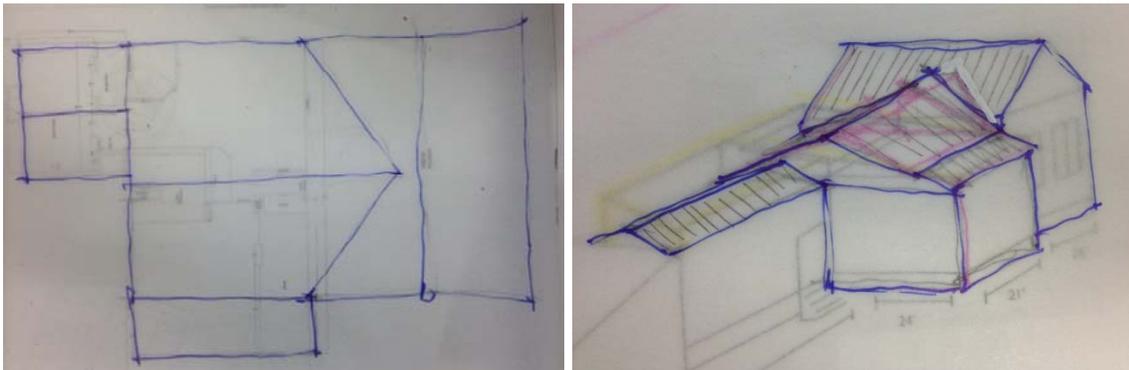
- **Roof:** Staff recommends than an architect be hired to do a formal roof plan to resolve the roof form issue. The roof configuration that is proposed, while it makes sense from a functional standpoint, is not appropriate from a form, massing, or roof line standpoint. Shed roofs that extend the entire width of the house are not typically seen in this area. Staff recommends considering a gable form over the rear as depicted below:

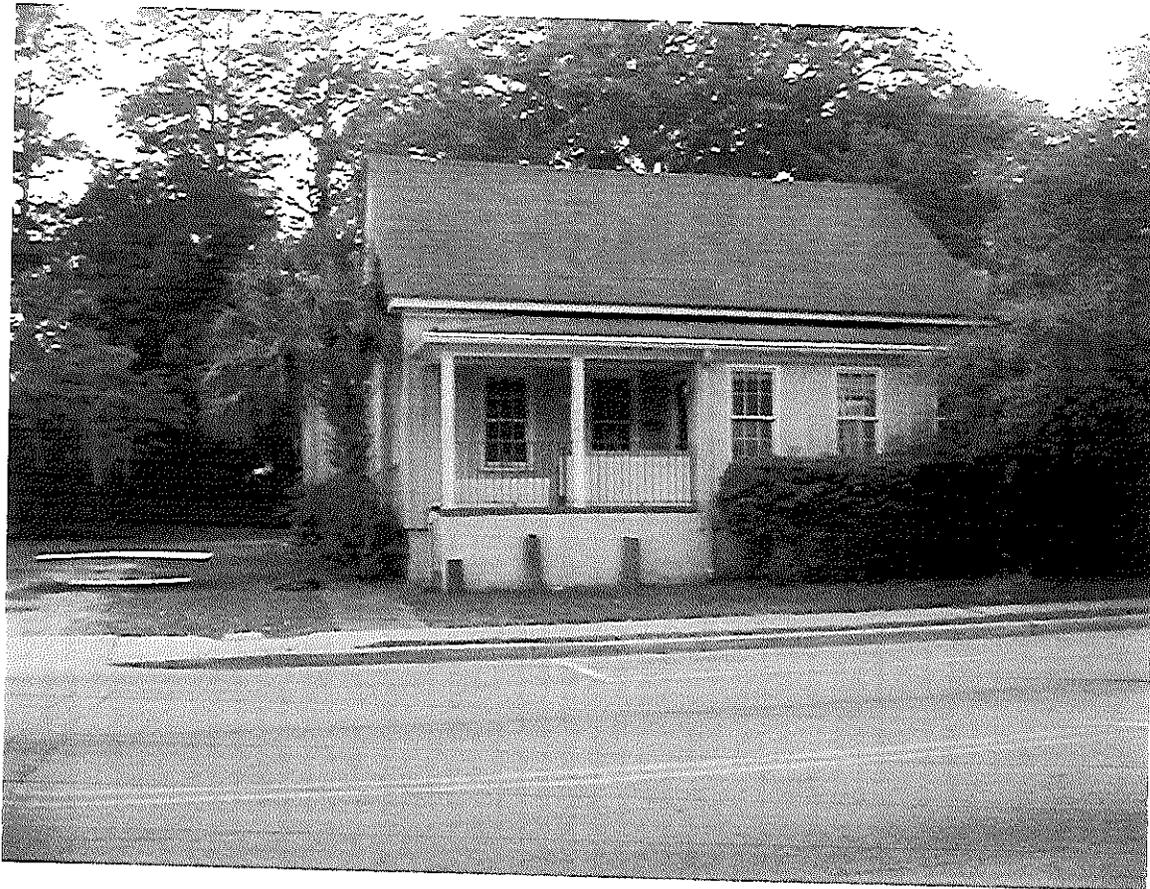
**EXISTING FRONT ELEVATION**  
**FACING CARTERET STREET**

Existing windows on the front are 2'-7" x 5'-2" w/ 7'-2" head height and are to be replaced with new insulated windows that are 3'-0" x 6'-0". On Photograph #4 you can see that the house framing is suitable for the new 3' wide window. Although the existing head height will be maintained because of its relationship to the front porch ceiling, there are no headers above these windows.

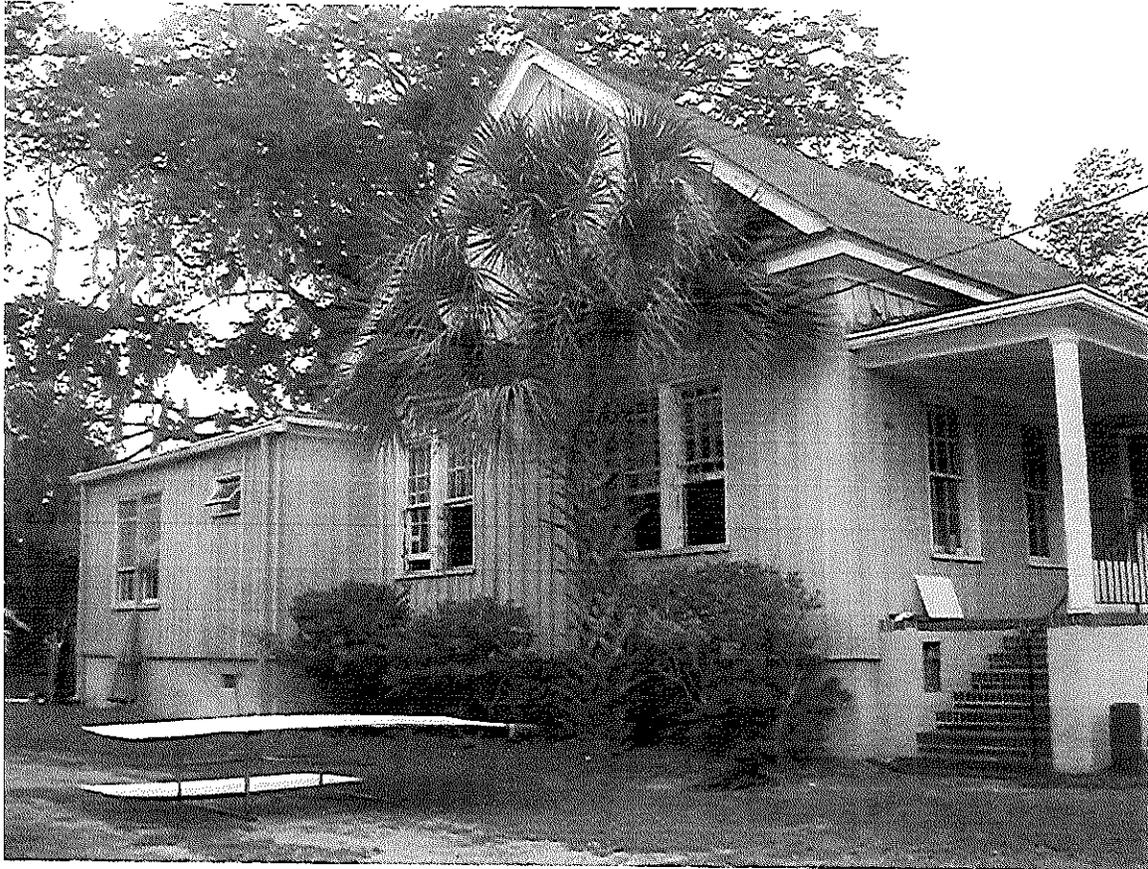
## EXISTING LEFT SIDE ELEVATION

OPPOSITE SIDE OF ORIGINAL HOUSE IS MIRROR IMAGE

Existing windows on the side are 2'-4" x 5'-6" with a 7" mull w/ 7'-11" head height. The four side windows that are on the original house are exactly the same on the opposite side. These double window units are to be replaced with new, insulated single window units that are 3'-0" x 6'-0". The same head height will be maintained.

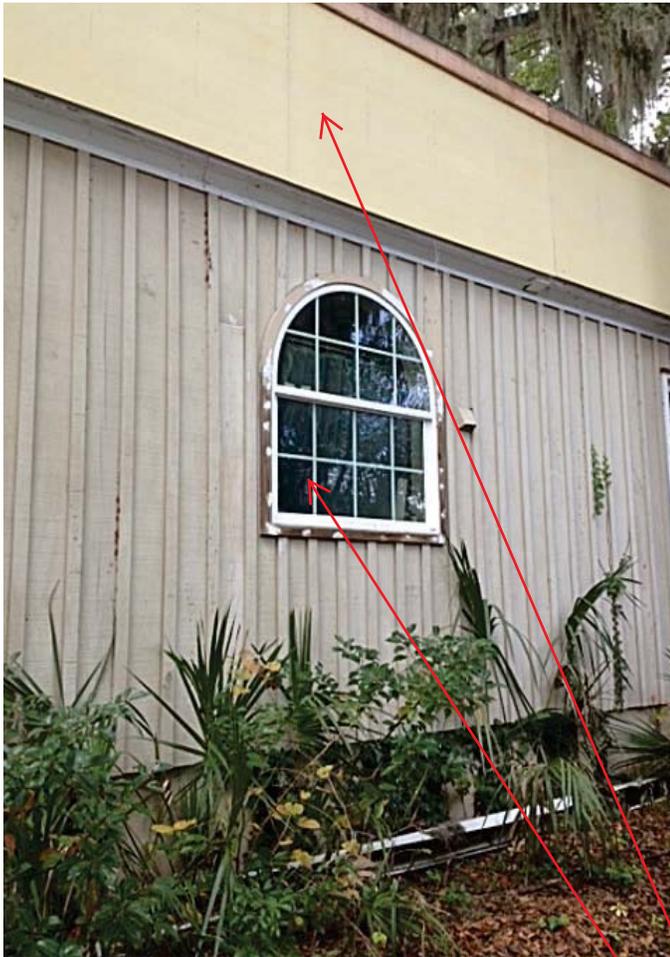
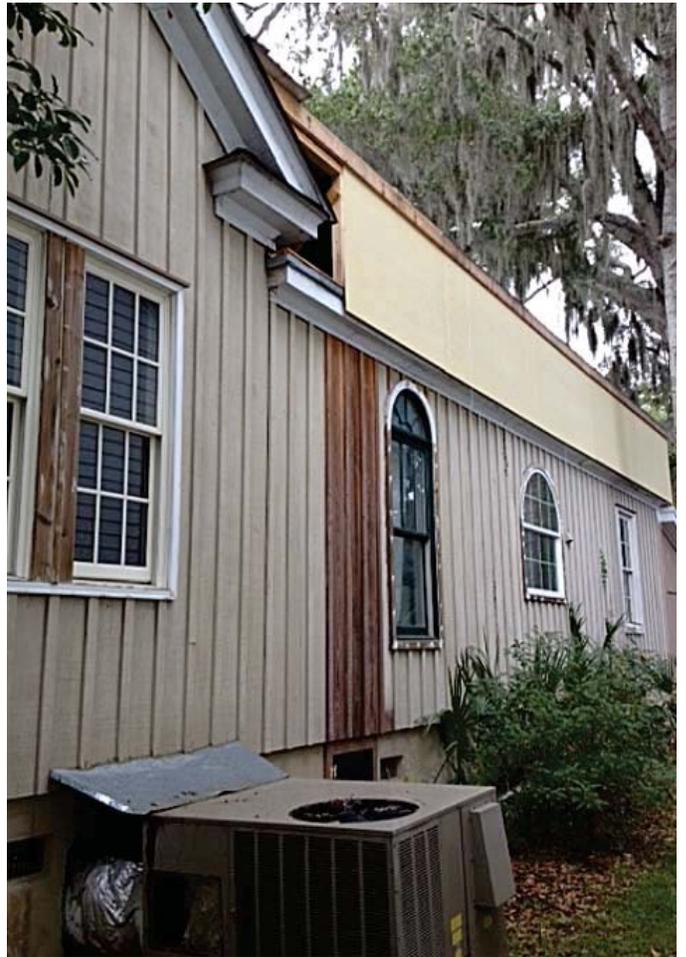
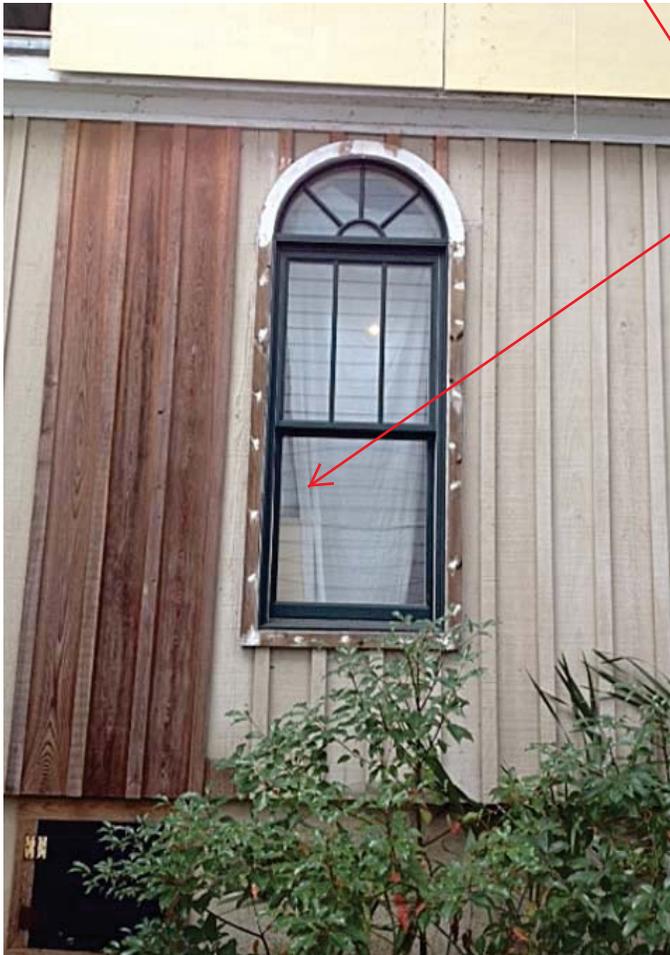
North Side of Building  
-extensive roof modification  
-new arched fixed window  
-new arched cottage-style window

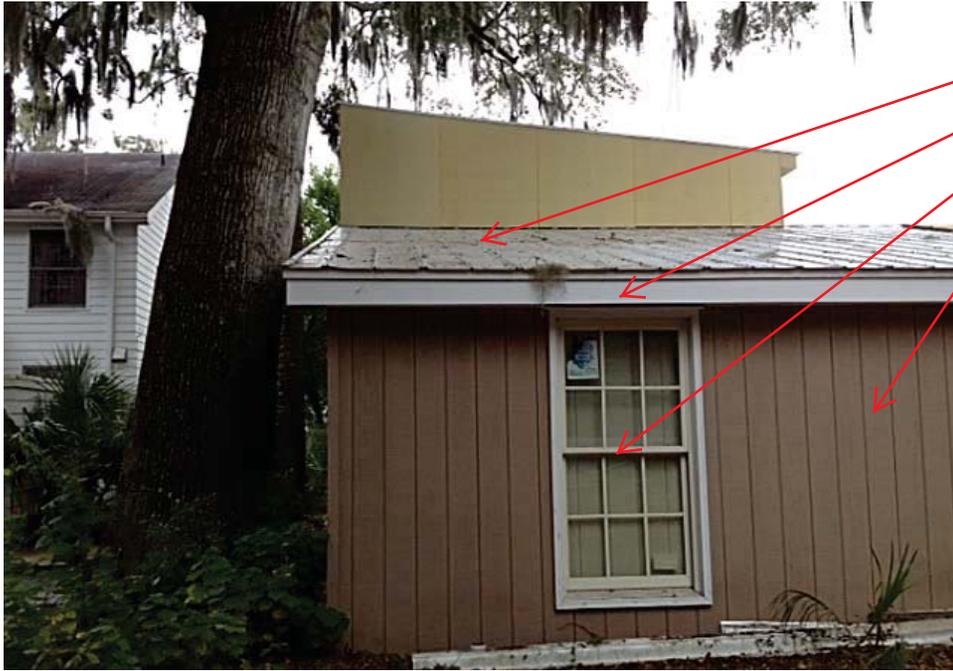
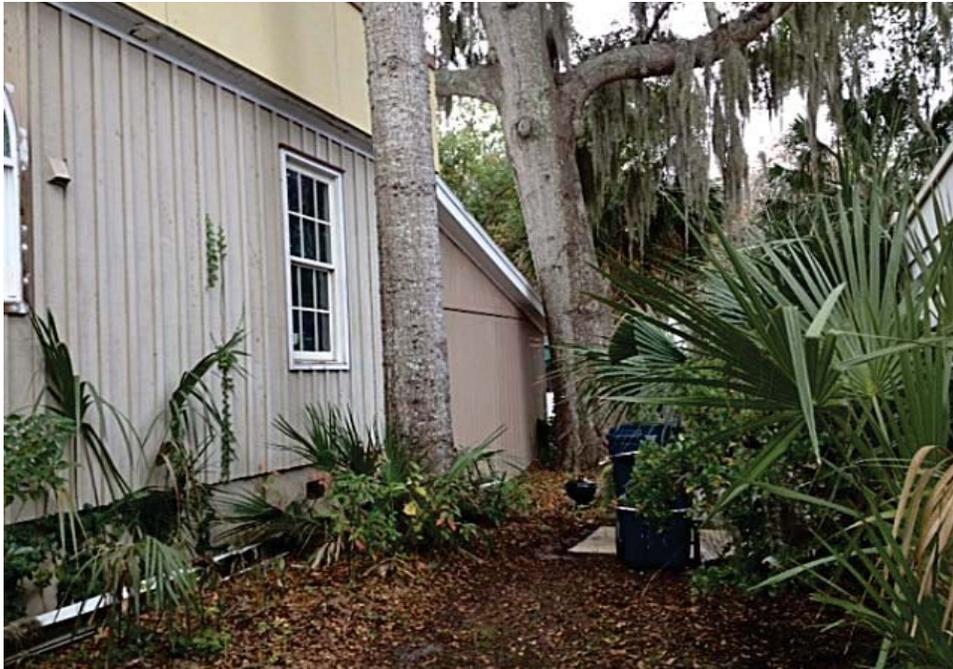
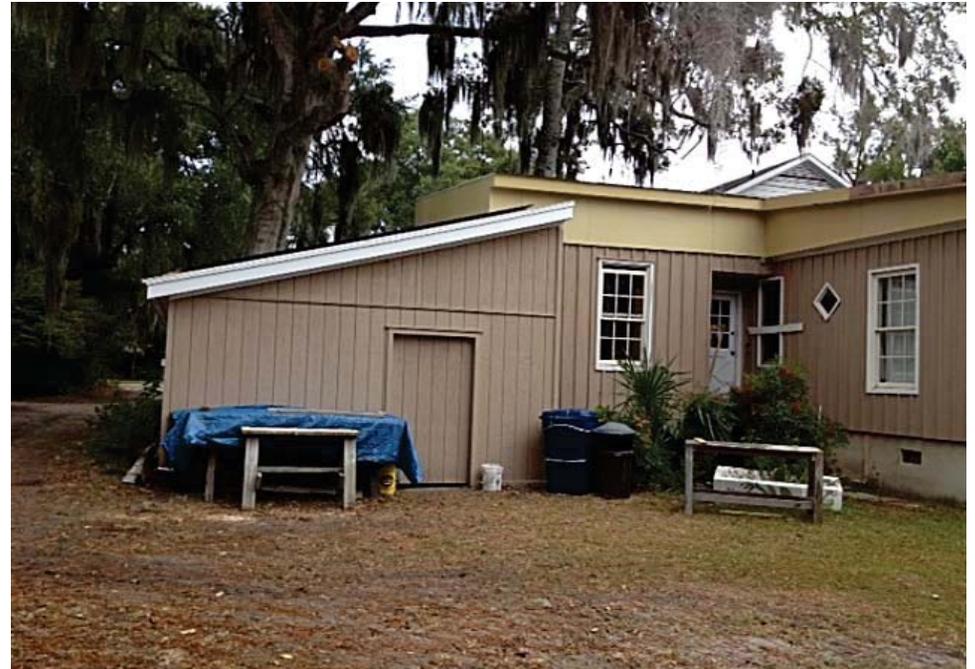
### Garage

- new roof
- new fascia
- new windows
- new siding
- concrete slab may be new as well

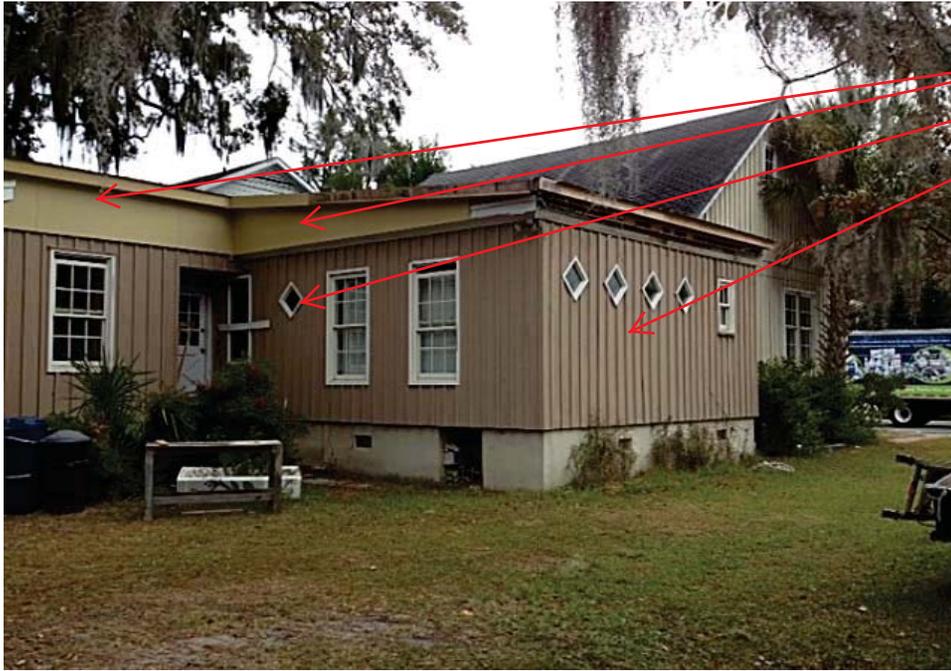
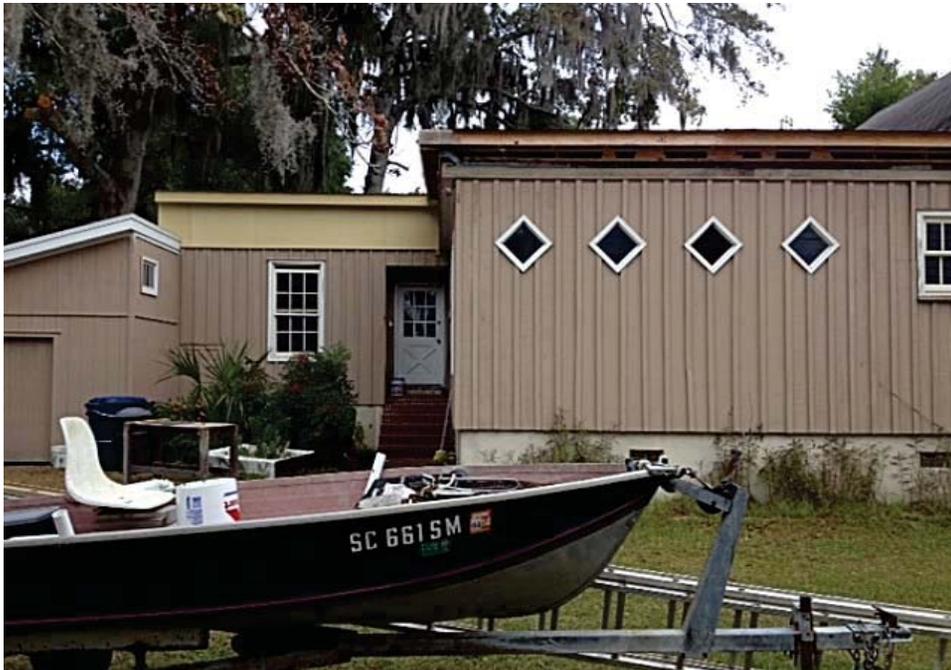
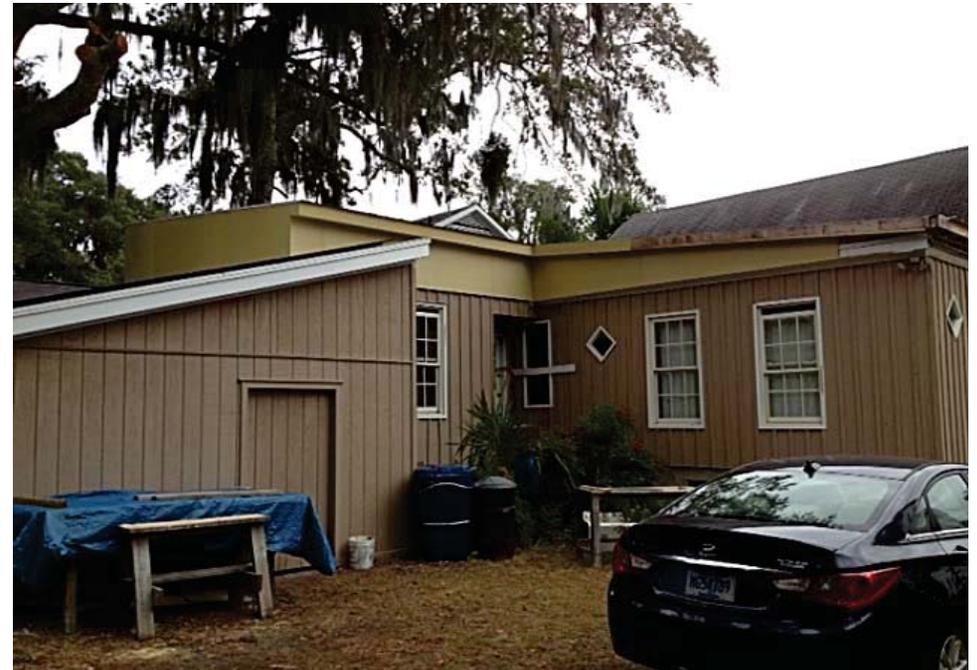
### South Side of Building

- roof modification
- a diamond-shaped window added onto rear
- a pair of double hung windows removed & replaced with 4 diamond-shaped windows

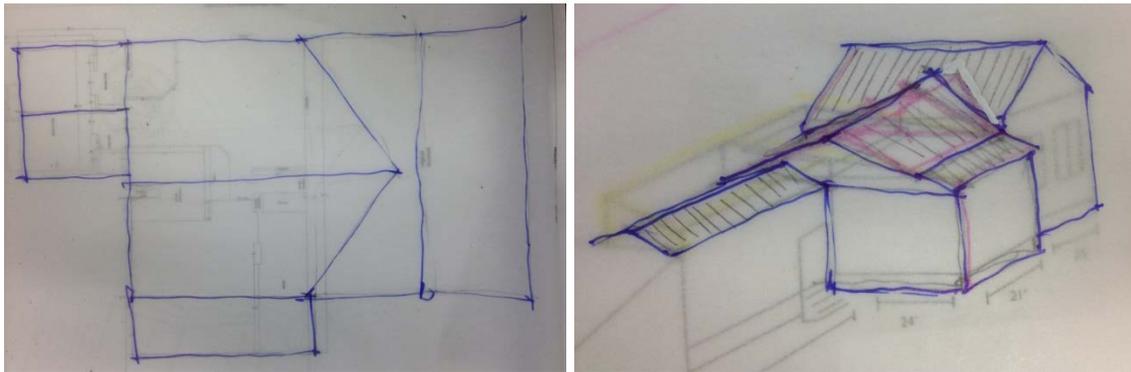
- **Roof:** Staff recommends than an architect be hired to do a formal roof plan to resolve the roof form issue. The roof configuration that is proposed, while it makes sense from a functional standpoint, is not appropriate from a form, massing, or roof line standpoint. Shed roofs that extend the entire width of the house are not typically seen in this area. Staff recommends considering a gable form over the rear as depicted below:

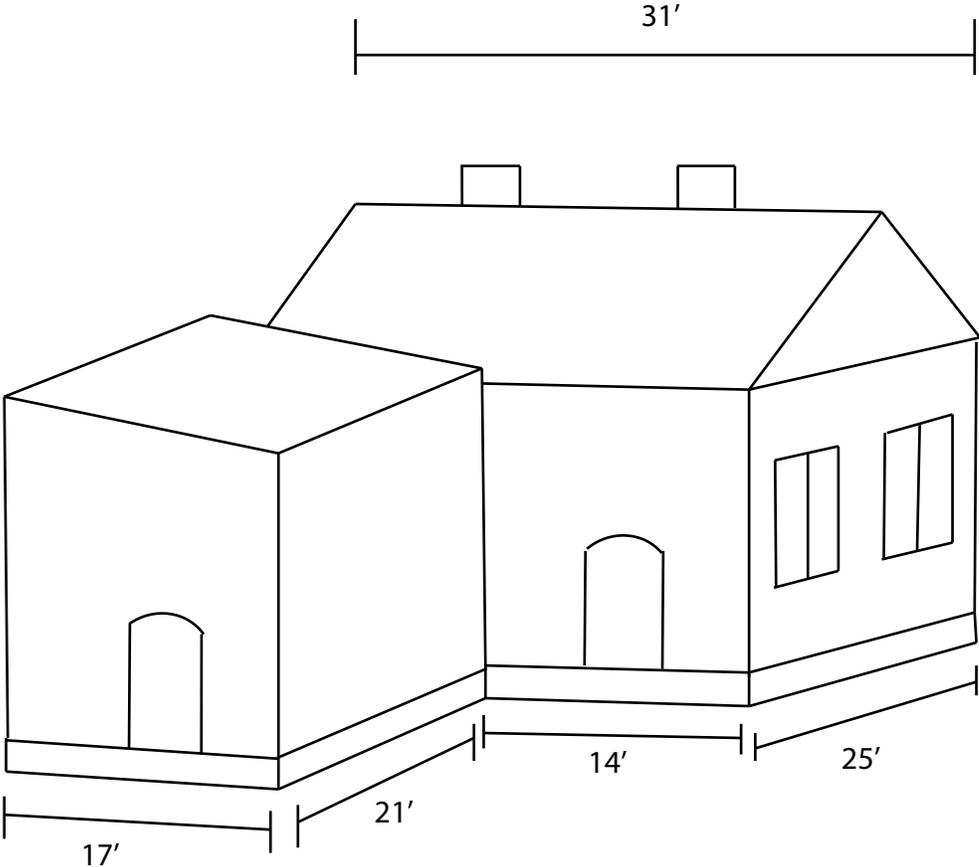
# Exhibit C

This describes the foot print and roof line of the building, as seen from the south side, as purchased in 2006 from St. Peter Catholic Church. Approximate square footage 2189.

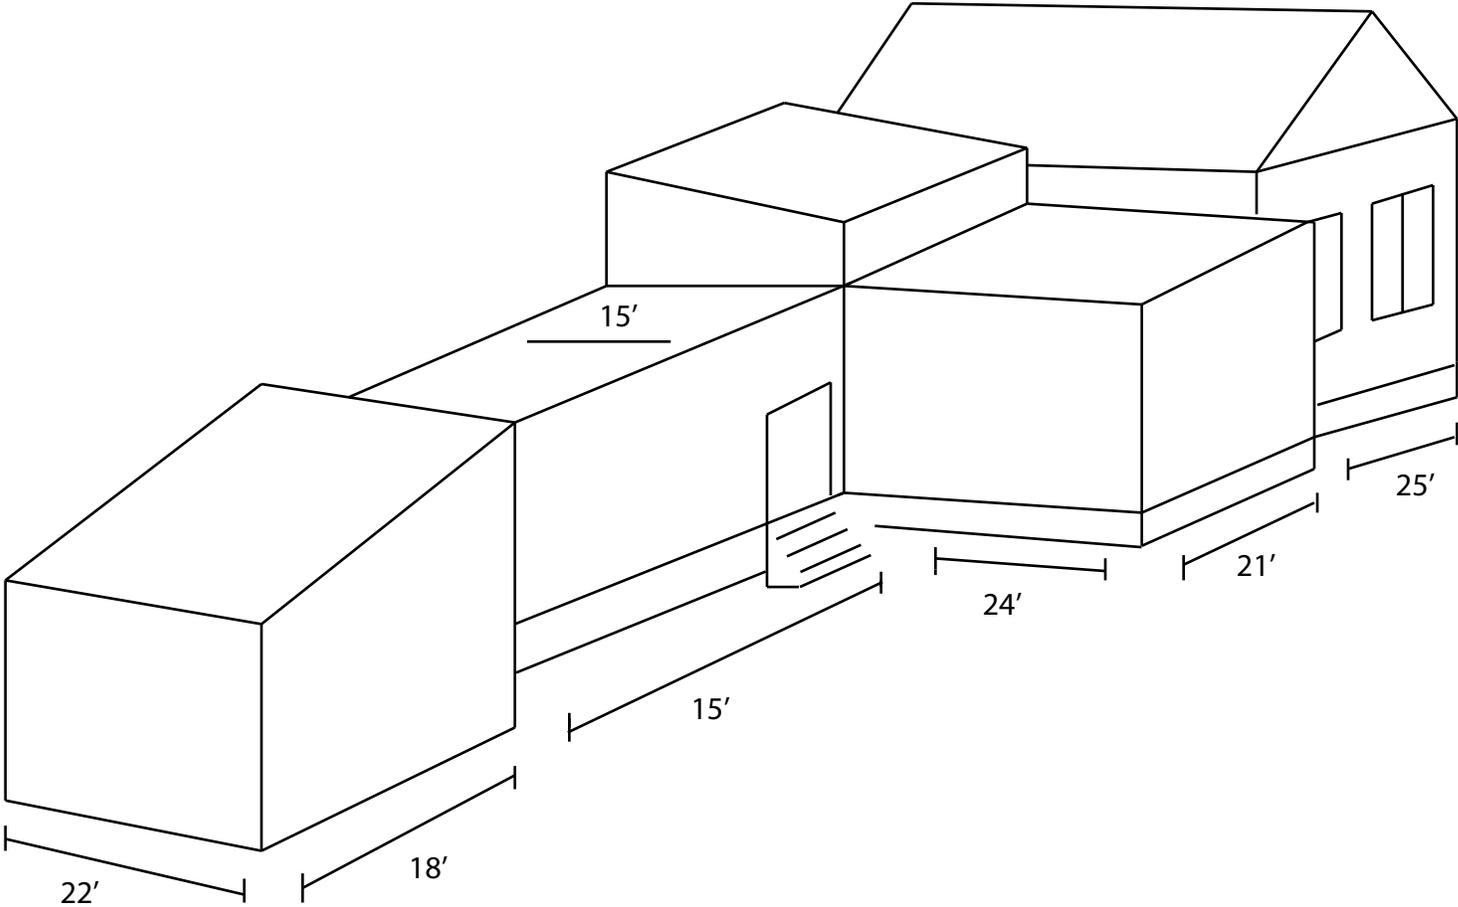
Exhibit D  
Roof line with revisions

This describes the foot print and roof line of the building as seen from the southerly view in 2014. The added sections are highlighted.

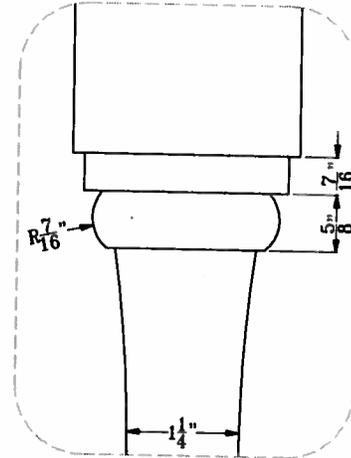
**A**  
1.0 **DETAIL - BALUSTER**  
ARCH. REF. N.A. SCALE 6"=1'0"

3/4" DIA. STEEL  
PIPE EXTENDED  
APPROX. 1-3/4"  
BEYOND ENDS  
OF BALUSTER
