**BEAUFORT COUNTY
HISTORIC SITES SURVEY - 1997**

INTENSIVE LEVEL BUILDING INVENTORY FORM

Site Number: U- 13 - 1151
Access County Site #
USGS Quad: 025 Beaufort
Doc. Level: Intensive Level-Building

Historic name(s): _____ Map Ref.: BFT 09 (BL) Tax Number: R120 004 000 0678 0000
Common name(s): _____ City Block Ref.: 98 .07 Island: Port Royal Is.
Address/location: 509 Harrington St. City/Vicinity of (vic.) Beaufort
Date: 1860 ca. Alteration date: 1990's
Ownership: 1. private 2. city 3. county 4. state 5. federal 6. unknown
Category: 1. building 2. site 3. structure 4. object
Historic use(s): multiple dwelling Current uses: single dwelling

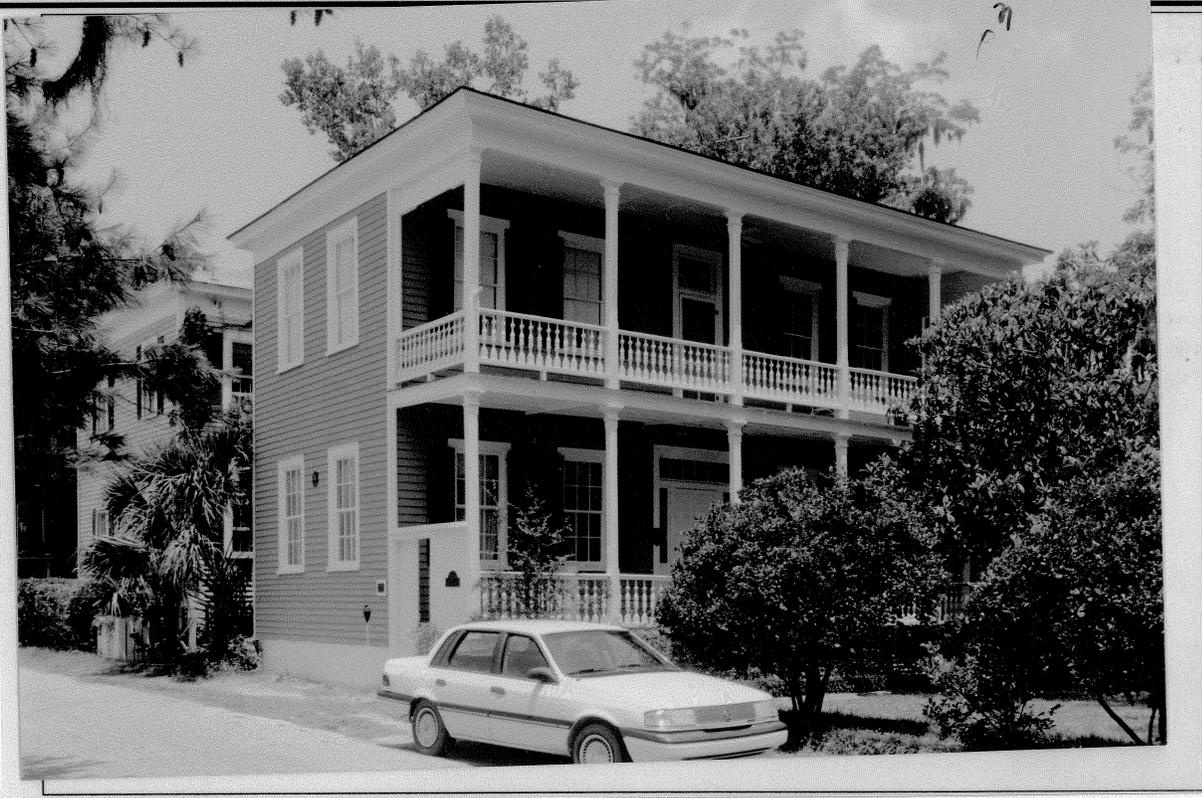
Photograph:

Date: 9/18/97 Recorder: C. Brooker, Brooker Arch. Cons. Roll # B-19 Neg. 21 View of: W facade & S elev., fac. NE

Description: 2 story framed dwelling facing south with 5 bay entrance facade. Entrance has sidelight and transom and is surrounded by frame with Greek Revival affinities. 2 story tiered porch is supported on slim chamfered posts and entered from street at lower level on W. side. Eaves cornice with wide overhang and deep frieze.

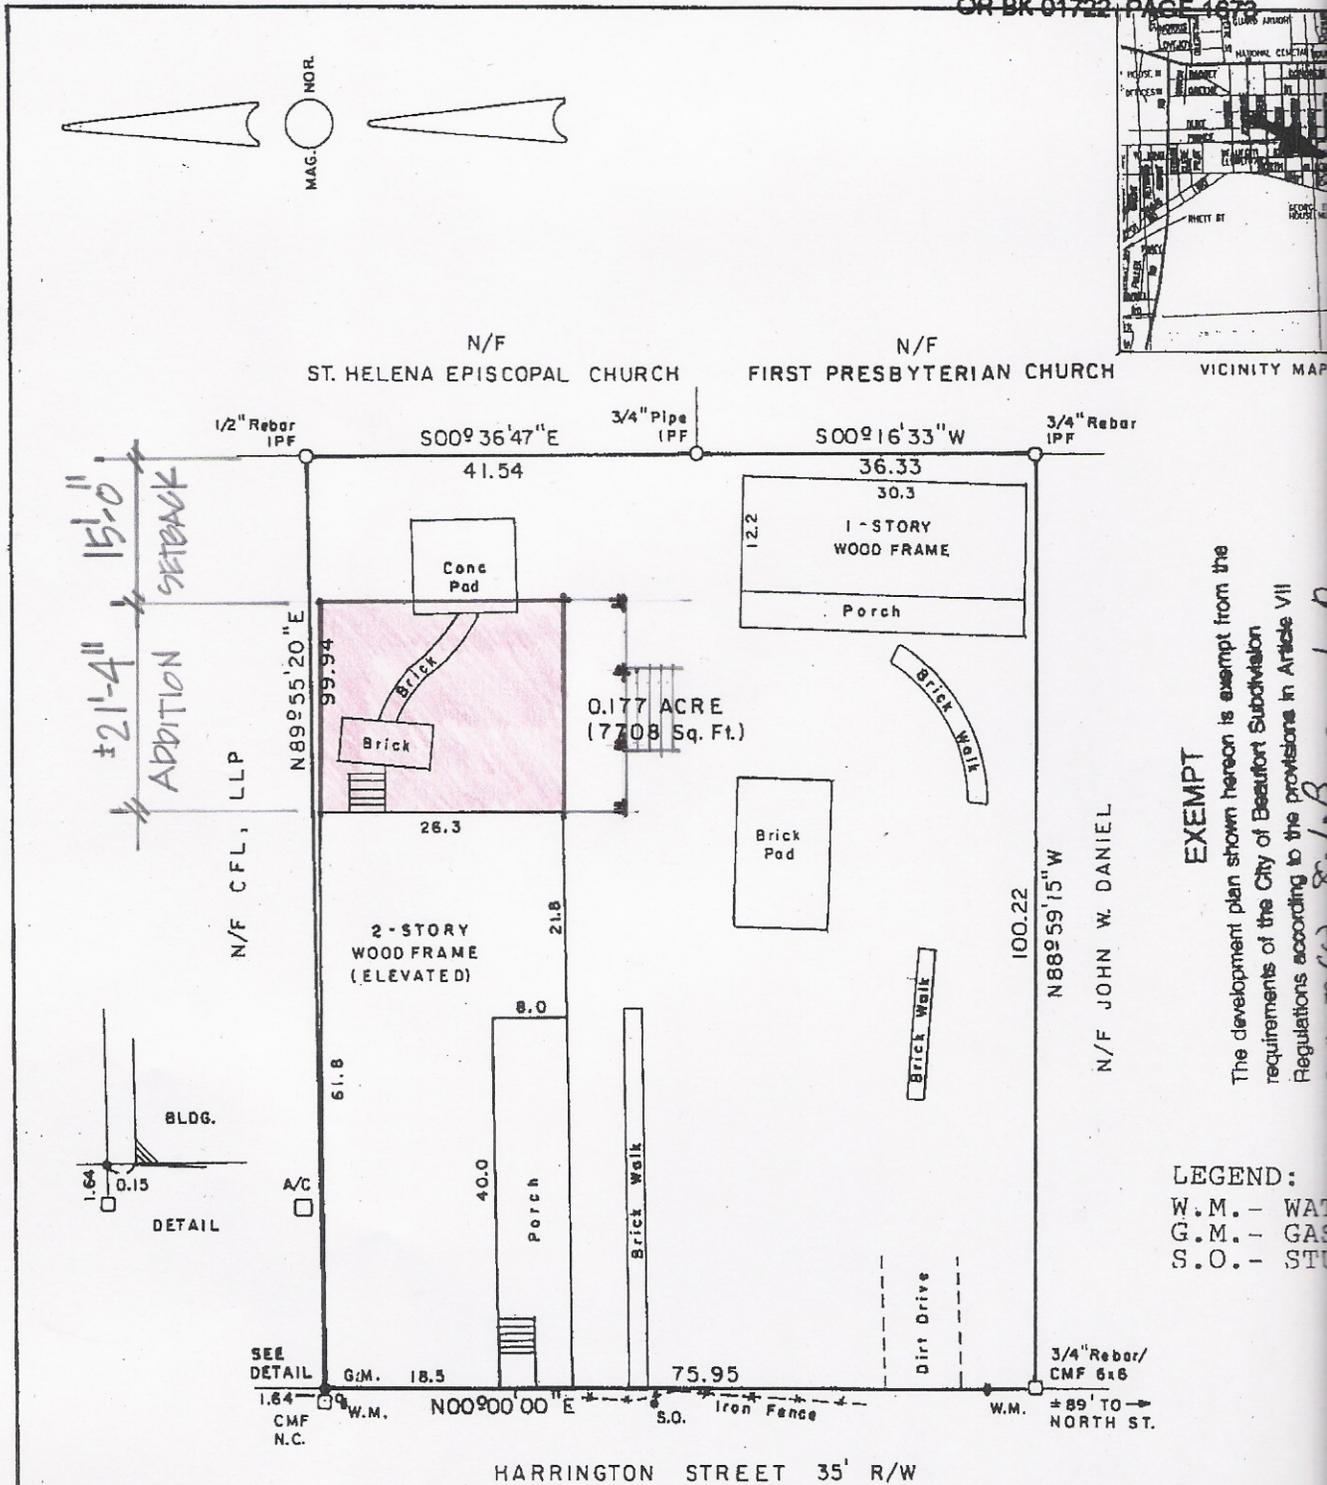
CLOSING PLAT PREPARED FOR ANN SHAW

THE SAME BEING A PORTION OF BLOCK 98, CITY OF BEAUFORT, BEAUFORT ACCORDING TO A MAP OR PLAT ADOPTED BY THE U. S. DIRECT TAX COMMISSION FOR THE DISTRICT OF SOUTH CAROLINA.

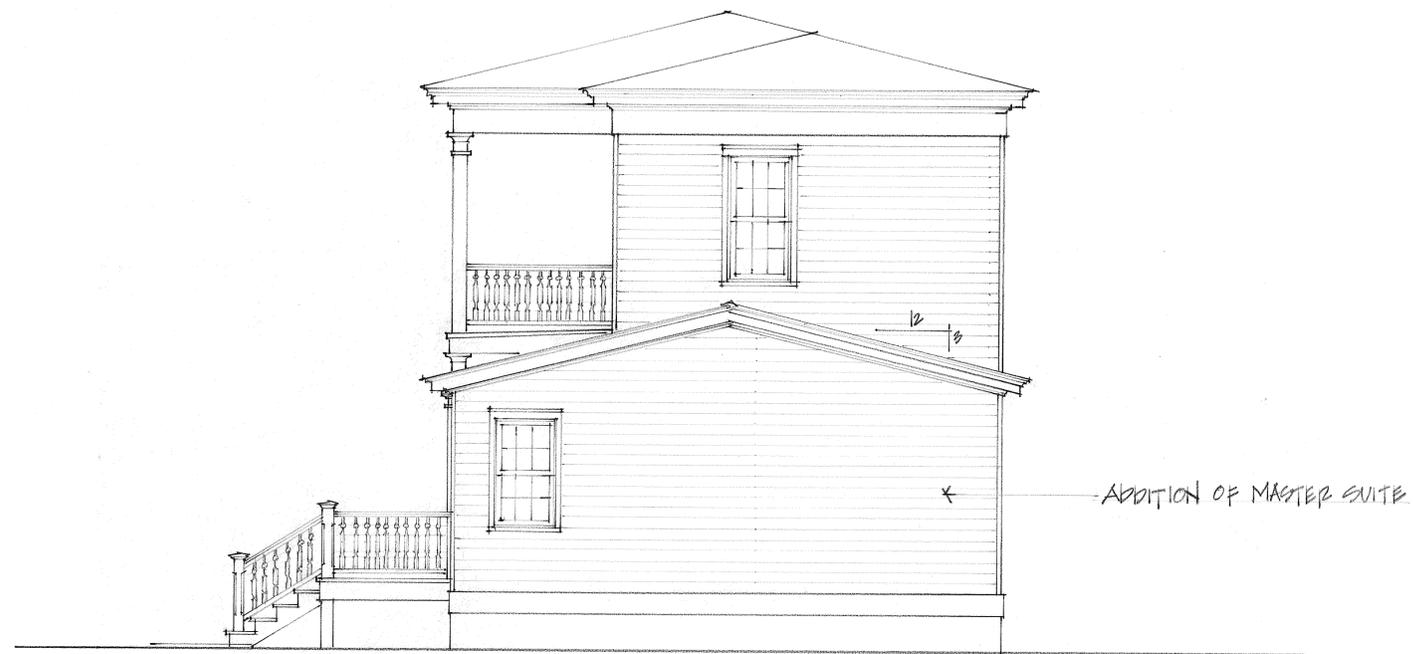
REAR ELEVATION

SCALE OF $\frac{1}{4}'' = 1'-0''$

CONCEPTUAL REVIEW FOR
THE CHERYL RESIDENCE 509 HARRINGTON STREET BEAUFORT, N.C. • MANUEL STUDIO, LLC • 23 JUNE 2014
