CITY OF BEAUFORT
Historic District Review Board
Full Board
Staff Report
Meeting of June 10, 2015

Case Number: HR15-16
Property Address: 1002 Church Street
Applicant: City of Beaufort
Type of Request: Demolition (Final Review)
Zoning: GR – General Residential – Northwest Quadrant

Request: **The city requests final approval for demolition of this structure.**

Visual Inspection of: 1002 Church Street

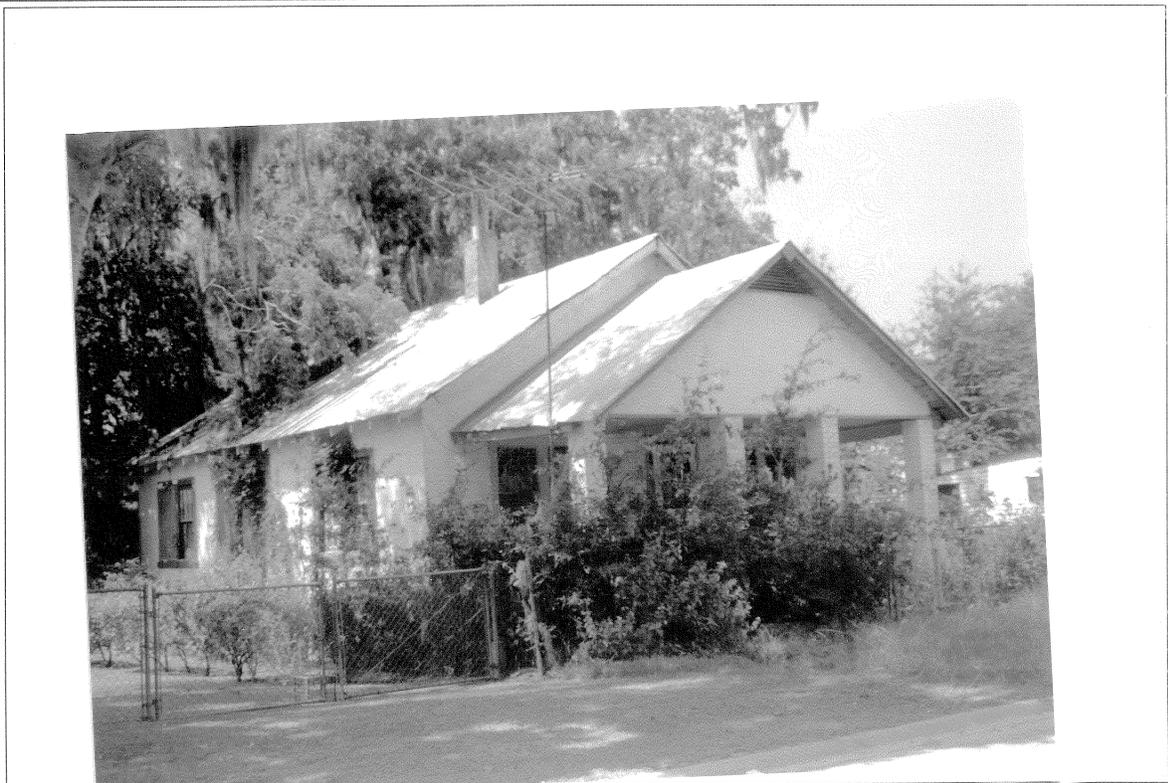
Photograph:

Notes: Rectangular 1 story 3 x 3 bay block dwelling w/front-facing gable roof

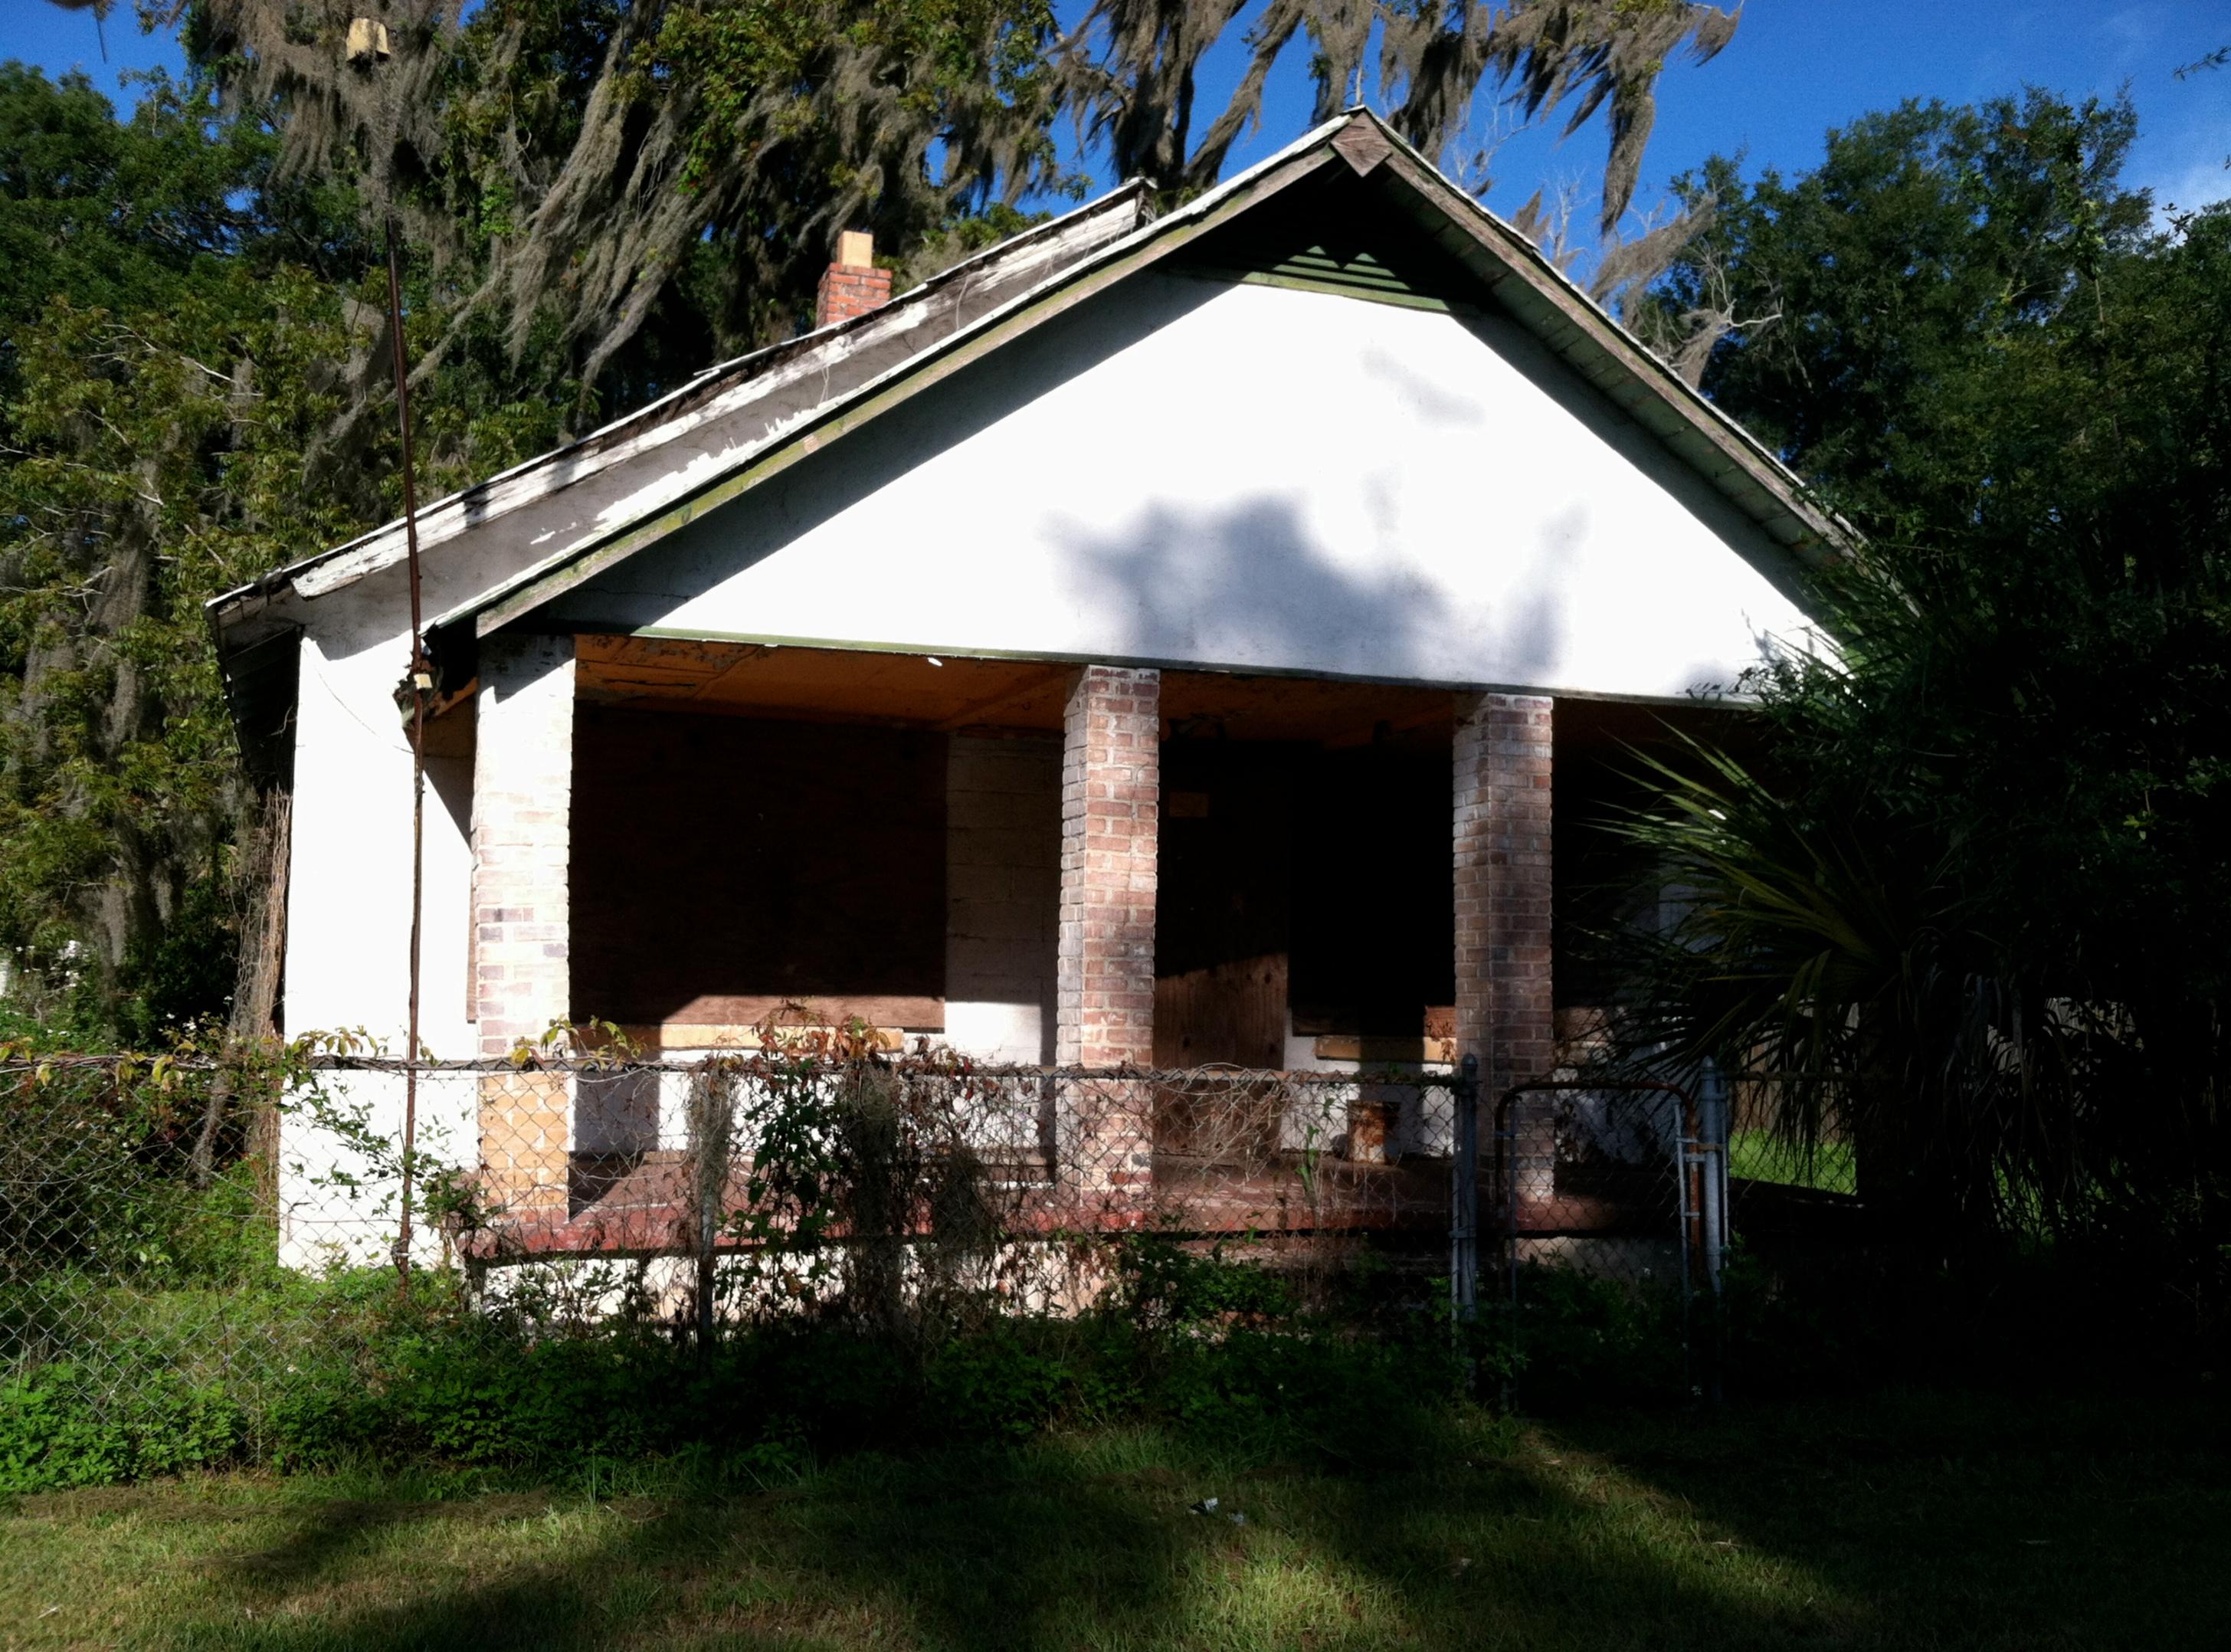
Roll # S-11 Neg. 10 View of: E facade & S elev., fac. NW

Notes: 1) Plant material is found growing on the North and South facades, as well as the East façade and porch, 2) Roof inspection may be necessary, exposed planks on the East façade gable are weather-worn, 3) Plywood sheet covering front entry standing ajar, not secured, 4) Paint on cinder block faces is worn, 5) East facade porch, left-most column is collapsing, and porch roof has minor bucking visible, 6) No such address visible, 7) No such sign visible

Unsafe/collapsing building additions must be removed. Contact the City Planning Department first for approval. Secure any openings left in the building with plywood painted the same color as the dwelling. (per IMPC 304.1.1, 304.4, 304.10, 305.1.1)
X	Porches, stairs and handrails must be maintained in a structurally sound condition and in good repair and capable of support imposed loads. Contact the City Planning Department before removing any porches, stairs, or railings. (per IMPC 304.10, 304.12)
X	Building must have address number (3-4") plainly visible from the street. (per IMPC 304.3)
	Provide termite treatment (recommended). (per IMPC 309.1)
	Have SCE&G remove the electric meter. (per IMPC 108.2.1)
X	Post property with "No Trespassing" sign. (per IMPC 108.2)
	For buildings in very poor condition, recommend having a licensed structural engineer experienced in working with historic structures provide a report and recommendations for proper stabilization.
